STRENGTHENING OF PRESTRESSED CONCRETE BOX BRIDGE AFTER FIRE EXPOSURE

This paper presents inspection, materials testing, field testing and parametric finite element analysis of a pre-stressed concrete box girder bridge after fire exposure. A detailed inspection of the fire-exposed bridge was performed through visual checking, photo examinations, and hammer detection. Samples of the concrete cores and reinforcing bars were tested; the residual strengths of the building materials (concrete, reinforcing bars and prestressed strands) were estimated. Furthermore, the temperatures at various depths were estimated. The data from field studies were used to validate finite element models. The structural behaviors of the original bridge prior to fire exposure were obtained via instrumentation from a reference bridge not exposed to fire. The static proof load test deflection results indicate that the stiffness decreased by approximately 23% after fire exposure and no longer satisfied the design requirement. The measured fundamental frequency of the fire-exposed span was approximately 97% of that of the original span and the theoretical fundamental frequency, indicating that the fire had littl

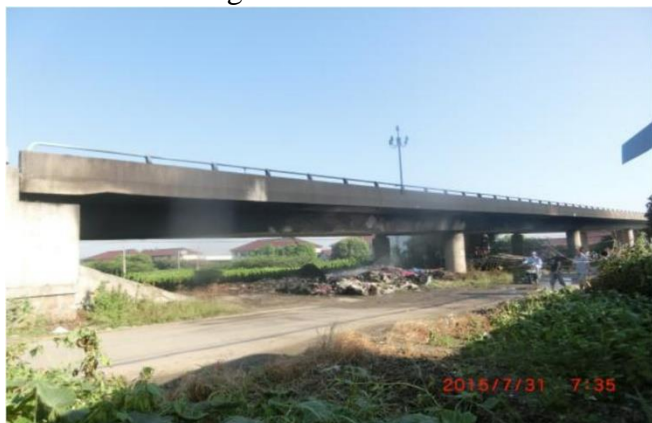
Fig. 4. Fire-damaged S12 bridge.

reported by highway patrols. The fire lasted approximately 2 h before firefighters approached and extinguished it with water at 4 a.m. According to the investigation results, the fire began in the textile wastes that were piled up below one span and propagated to nearby scrap wood below an adjacent span; however, the cause of the fire remains unclear. The vertical clearance below spans 1 and 2 is approximately 4 m. According to the extents of burning embers below the spans, the fire-affected area below each span is approximately $6 \times 15 \text{ m}^2$. The fire accident damaged the bridge elements, i.e., the

beams, columns and bearings, to various extents. The CHD Engineering Center, Inc., arrived at the fire site at 7 a.m. on the same day and performed a fire damage inspection. According to the results of the initial inspection, the S12 bridge was partially damaged by the fire, and the structural performance of the bridge was thought to have possibly decreased after the fire exposure. Therefore, the S12 bridge was immediately closed to traffic, and detour roads were soon arranged.

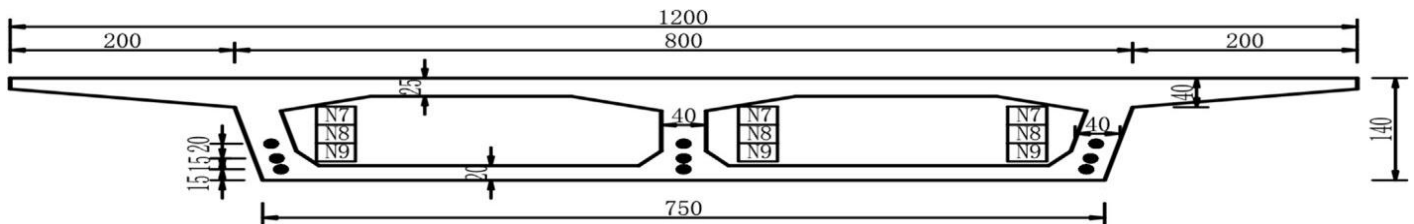
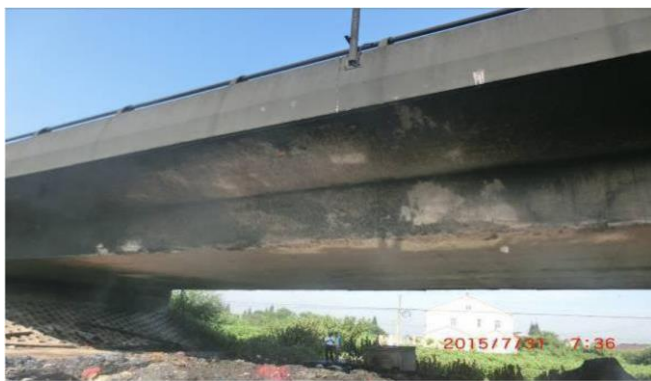
Fig. 6. Fire-damaged span 1.

The fire damage patterns indicated that the fire-damaged portions were mainly within span 1 (Fig. 6) and span 2 (Fig. 7). The typical damage on abutment 0 was soot on the front-wall surface and a light pink color and map cracking on parts of the surface concrete. No concrete spalling was observed on the abutment elements. The fire damage to the beam elements is summarized in Table 1, and a schematic of the damage to the spans is plotted in Fig. 8.

Span	Element	Damage description
span 1	right flange	Soot throughout the span, pink in the midspan ranging from 9.3 to 16.8 m, map cracking in 80% of the area with a crack width of less than 0.15 mm, cover loss in certain areas.
	right web	White-gray color ranging from midspan to pier 1, soot adjacent to abutment 0 and pink in the transition zone, rough map cracking in 40% of the area, clear concrete spalling ranging from 9.6 to 17.2 m, a maximum gap depth of 4.3 cm, and reinforcement exposed near the soffit.
	soffit	White-gray color ranging from midspan to pier 1, soot adjacent to abutment 0 and pink in the transition area, rough map cracking in 40% of the area, significant concrete spalling ranging from 3.8 to 23.8 m, a maximum gap depth of 4.3 cm, and reinforcement exposed in the area corresponding to the middle web.
	left web	Soot throughout the span, white-gray color in the midspan near the soffit, local rough map cracking, concrete spalling ranging from 5.6 to 15.6 m, a maximum gap depth of 3.5 cm, and reinforcement exposed near the soffit.

left flange	Soot throughout the span, no clear cracking, spalling or cover loss.
	others	The bottom corrugated pipe in the right web was exposed with a drill, and the pipe shape remains. The pattern on the surface was blurred and melted. Part of the corrugated pipes of the web tendon in the severely damaged area, located 15 cm from the bottom and 19.4 cm from the edge of the right web, was removed and tested in the laboratory, and the testing results are provided in subsequent sections.
span 2	right flange	Soot throughout the majority of the span, pink within 5 m located at L/4, map cracking in these areas, and a crack width of less than 0.15 mm.
	right web	Soot throughout the span, white-gray color near L/4, pink in the transition area, rough map cracking in 10% of the area, significant concrete spalling ranging from 9.6 to 15.7 m, and a maximum gap depth of 3.5 cm.
	soffit	Soot throughout the span, white-gray color near L/4, pink in the transition zone, rough map cracking in 15% of the area, local concrete spalling ranging from 9.6 to 15.7 m and 5-10.8 m on the left side and from 4 to 10.4 m in the middle area, with a maximum gap depth of 5.5 cm.

left web	Soot throughout the span, white-gray color near L/4, pink in the transition area, rough map cracking in 15% of the area, local concrete spalling ranging from 5.0 to 10.8 m, a maximum gap depth of 3.5 cm, and no reinforcement exposed.
	left flange	Soot throughout the span, no clear cracking, spalling or cover loss.
	others	In part of bar in the severely damaged area located at L/4 corresponding to the position of the middle web, the surrounding concrete was removed, and the bond with the reinforcement remained good.

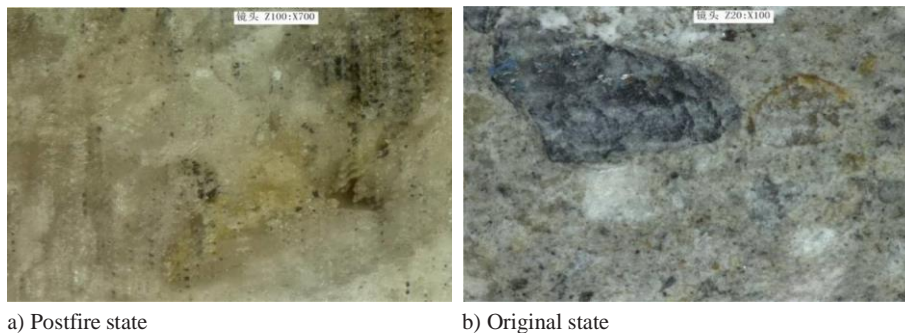
Fig. 10. Petrographic photographs of various states of concrete.

A postfire concrete sample taken from a depth of 5 cm was also checked via petrographic examination to distinguish the damage extent

and property changes of the heated concrete, i.e., the depth of micro-cracking, paste alteration (color change and strength softening) and carbonation. The temperatures at various depths of the inner concrete can be estimated according to the petrographic examination results obtained using an electron microscope. CECS 252 [8] suggests the changes in the microcharacteristics of concrete corresponding to various temperature ranges. Fig. 10 a) shows a petrographic picture taken from a depth of 5 cm from the concrete surface in a postfire beam. The color of the sampling was white-gray, the cement remained tense with good integrity, and no microcracking was found. According to a comparison of the petrographic results with CECS 252 [8], the temperature of the concrete at a depth of 5 cm was estimated to range from 350 °C to 550 °C during the fire. Fig. 10 b) shows the original concrete surface unexposed to fire.

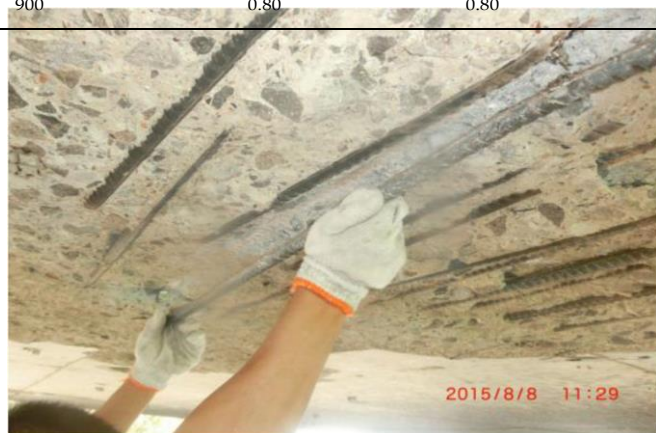
Fig. 11. Bar sample from the soffit.

reinforcing bar tensile strength under various exposed temperatures are summarized in Table 4 from CECS 252 [8]. Following the recommended assessment method, three segments of the HRB335-type reinforcing bar with a 16 mm diameter were taken from the soffit (Fig. 11) and tested via

tensile tests (Fig. 12) to ascertain the postfire bar tensile strength. According to the test results, the minimum yield strength of the postfire bar was 348.3 MPa. In addition, the initial records of the bar in the construction stage were checked, and the recorded original minimum yield strength of an HRB335 bar with a 16 mm diameter was 412.5 MPa. Hence, the calculated reduction coefficient of the bar was approximately 0.85, which corresponds to the recommended value at 700 °C. This result indicates that the temperature of the testing bar reached 700 °C during the fire exposure. Because the concrete cover spalled off during the fire, the sampled segments of the reinforcing bar were exposed. Accordingly, it is inferred that the beam surface temperature reached 700 °C during the fire.

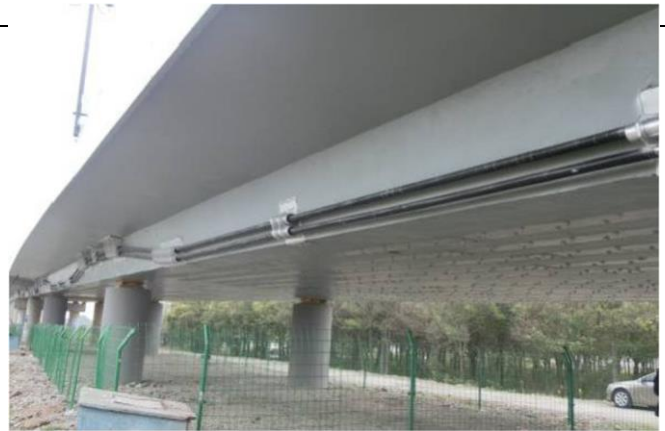
Fig. 26. External prestressing strengthening at webs.

Based on all the investigations and analyses conducted, it was evident that the mechanical properties of the materials of the S12 bridge were degraded. Furthermore, the residual loading capacity and stiffness of the S12 bridge were reduced and could not satisfy the design requirements. To restore the structural performance and enhance the durability and safety of the fired bridge, a set of repair measurements were determined and undertaken as follows: 1) the influenced surfaces of box beams and piers were flushed and cleaned; 2) spalling and de-laminated concrete were removed to depths of 2–8 cm according to the damage extent, exposed rebar was derusted by sand blasting and

broken sections were fixed with polymer mortar, including girders, abutment and piers; 3) the whole continuous unit 1 was strengthened by external prestressing with four strands fixed at lateral webs, as
