## INVESTIGATION OF ENVIRONMENTAL IMPACTS ON SANDSTONE BLOCKS AT LUXOR TEMPLE AND CONCEPTS FOR CONSERVATION

Dr. Elashmawy Abd -Elkareem Ahmed

Sandstone blocks were used in the construction of Luxor temple. However, they, especially cement materials, were at a great risk because of being affected by various deterioration factors. Groundwater started to rise in and around the temple, causing serious deterioration aspects of the blocks. Therefore, the current study was conducted to focus on the role of pores and cement regarding the deterioration process of sandstone blocks in the temple. In order to conduct systematic investigation, it adopted SEM – EDX, PLM and XRD. Also, physical and mechanical properties were examined to evaluate the components of the sandstone, under the present environmental conditions. It also interpreted the investigations of on-site evaluation tests (non- and less-destructive). It also focused on other methods, e.g. humidity and salt analysis. The study ended develops some recommendations that fit sandstone address in Luxor Temple.

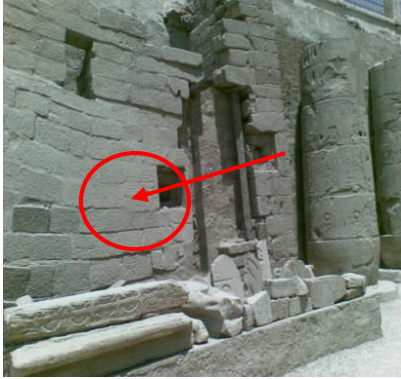
**Fig. (6) Differential tendency on the walls of Luxor temple**

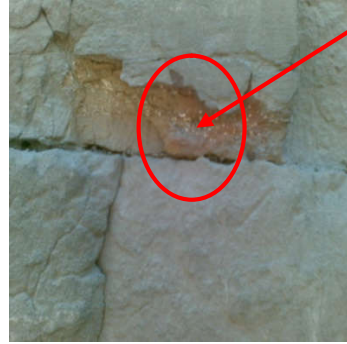
**Fig. (7) Stress on the lower parts of Luxor temple's walls**

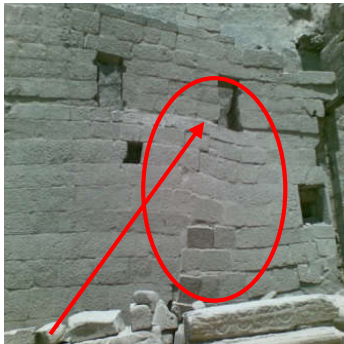
**Fig. (8) Differential tendency on the walls of Luxor temple**

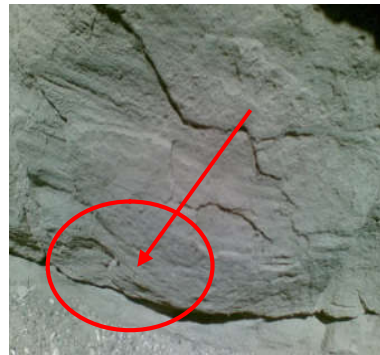
**Fig. (9) Soil on the lower parts of Luxor temple's walls**

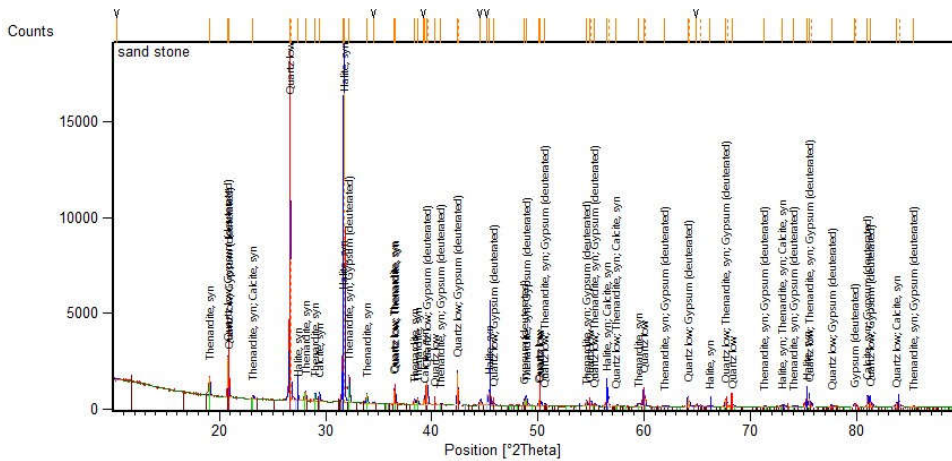
XRD patterns showed that quartz ( $\text{SiO}_2$ ) was the main component of the temple's sandstone, with subordinate amounts Calcite ( $\text{CaCO}_3$ ) and halite ( $\text{NaCl}$ ), thenardite ( $\text{Na}_2\text{SO}_4$ ) & gypsum ( $\text{CaSO}_4 \cdot 2\text{H}_2\text{O}$ ) (Fig.10 a & b). These results proved that the stone used in the temple was Nubian sandstone [37]. Damage to sandstone was caused by the mechanical stress, which was induced by halite, thenardite & gypsum crystallization cycles and calcite which may be cement in sandstone.

**Fig. (10 a&b) A sample of sandstone taken from Luxor temple analyzed by XRD.**
