The Effect of Artificial Aging and Surface treatments on Microtensile Bond Strength of Resin Cement to Hybrid Ceramics

Hassan Shohdy, Engy I.; Nossair, Shereen A.; and Hamdy, Amina M. (2019) "The Effect of Artificial Aging and Surface treatments on Microtensile Bond Strength of Resin Cement to Hybrid Ceramics," *Future Dental Journal of Egypt*. Vol. 5 : Iss. 1 , Article 4.

Purpose: To assess the effect of aging and various surface treatments on the microtensile bond strength of resin cement to two hybrid esthetic materials.

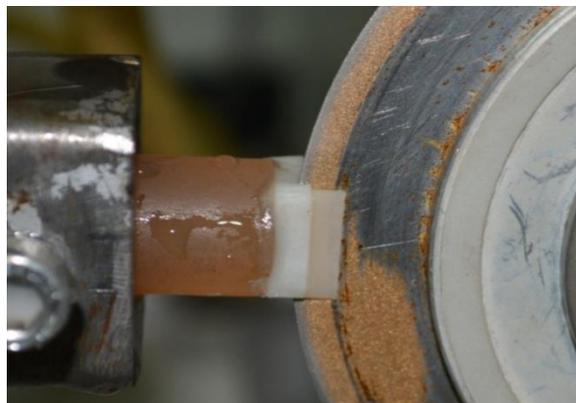
Fig. 1: Ceramic- composite resin block vertically sectioned into serial slabs

The ceramic-composite resin blocks were fixed on epoxy resin cylinders, and each was vertically sectioned into serial slabs using water cooled diamond blade with a low speed cutting saw (**Fig. 1**). It was then rotated 90° to

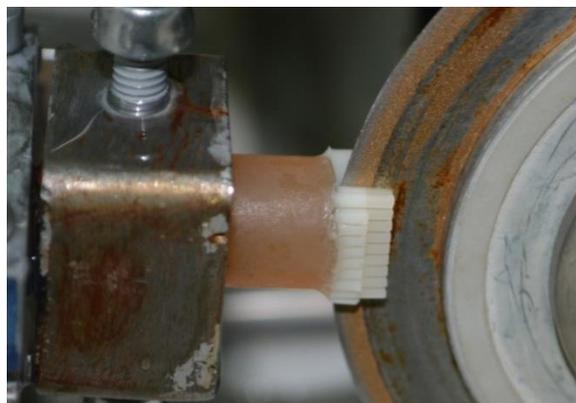
Fig. 2: The ceramic- composite resin block rotated 90° to make additional vertical cuts

make additional vertical cuts (**Fig. 2**), so that the ceramic-composite resin block has perpendicular cuts (**Fig. 3**) to obtain a thin long micro-beam with the following dimensions (1 mm × 1 mm × 6.1 mm) with an overall cross-sectional area of approximately 1 mm². The microbeams were further measured with a digital caliper before bond strength testing as shown in (**Fig.4**).

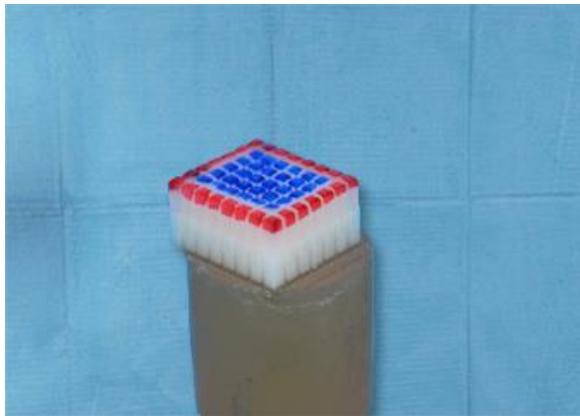
Fig. 3: The ceramic-composite resin block with perpendicular cuts, Red color represents the excluded micro-beams while the blue color represents the used micro-beams

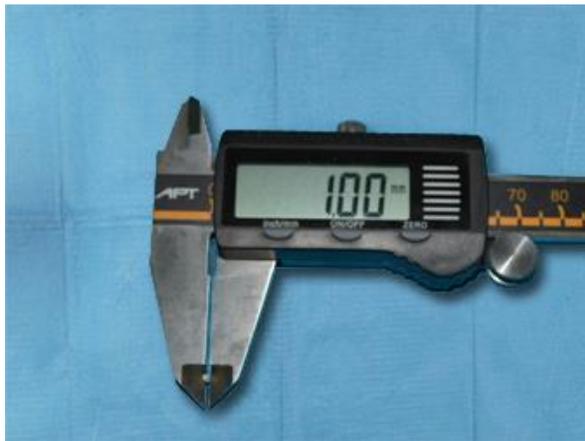
Fig. 4: A micro-beam of 1mm² cross-sectional area

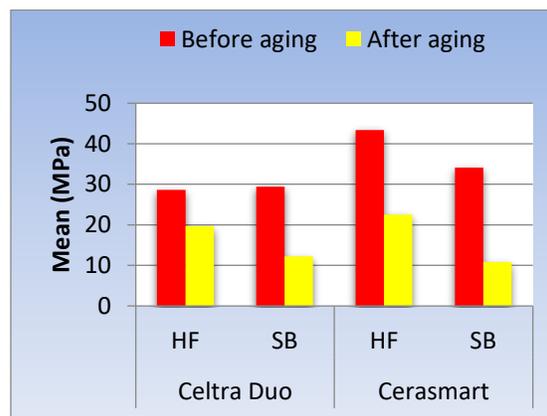
Fig. 5: Bar chart representing mean micro-tensile bond strength before and after aging of each ceramic type with each surface treatment

Statistical analysis showed that there was a statistically significant decrease in mean μTBS after aging in table (2). Using either ZLS or RNC whether with HF or SB, there was a statistically significant decrease in mean μTBS after aging (Fig. 5). In case of ZLS with HF, μTBS was significantly higher before aging (28.6 ± 4.0 MPa) than after aging (19.7 ± 4.9 MPa), and with SB it was also significantly higher before aging (29.4 ± 5.4 MPa) than after aging (12.2 ± 2.9 MPa). In case of RNC, the results were significantly higher with HF before aging (43.4 ± 3.4 MPa) than after aging (22.5 ± 3.1 MPa) as well as SB in which the μTBS was significantly

higher before aging (34.1 ± 6.7 MPa) than after aging (10.8 ± 2.5 MPa).

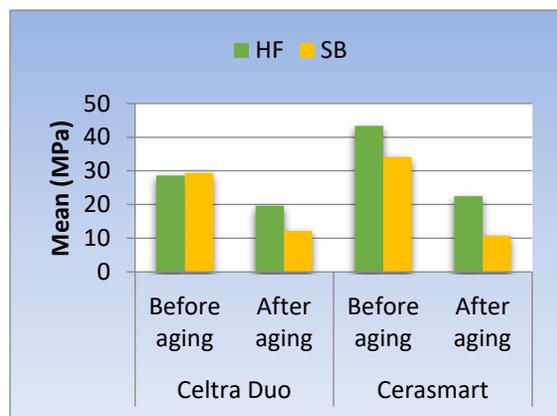
Fig. 6: Bar chart representing mean micro-tensile bond strength of the two surface treatments with each ceramic type before and after aging

Regarding the surface treatment, HF showed statistically significant higher mean μTBS than SB as shown in (Fig. 6). Before aging, ZLS showed no statistically significant difference between mean μTBS values of HF (28.6 ± 4.0 MPa) and SB (29.4 ± 5.4 MPa) as shown in table (3). After aging, HF acid etching (19.7 ± 4.9 MPa) showed statistically significant higher mean μTBS than SB (12.2 ± 2.9 MPa). Using

RNC whether before or after aging, HF showed statistically significant higher mean μ TBS than SB. Before aging, HF was (43.4 ± 3.4 MPa) while SB was (34.1 ± 6.7 MPa). And after aging, HF was (22.5 ± 3.1 MPa) while SB was (10.8 ± 2.5 MPa)

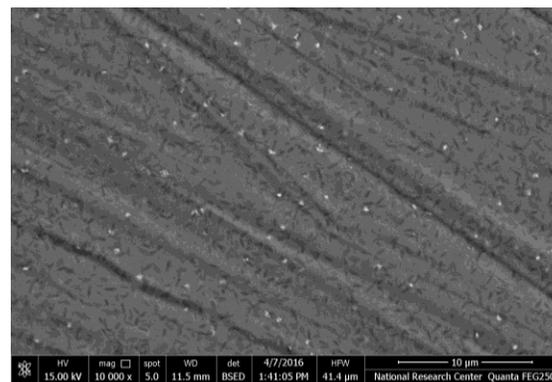
Fig. 7: ZLS plate (10000X) with no surface treatment

SEM results showed that ZLS plate with no surface treatment showed a smooth surface which consists of a glassy phase rich in lithium silicate crystals and characteristic dispersed zirconia fillers with striations due to polishing procedures as in (Fig.7). While after the HF, it showed a honey-comb-like micro-rough porous

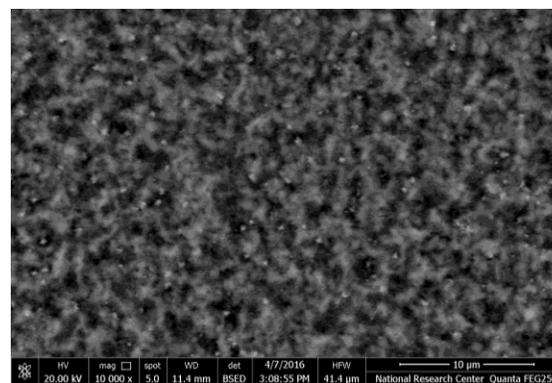
Fig. 8: ZLS plate (10000X) treated with hydrofluoric acid etch

surface due to HF- acid etching procedure as shown in (Fig. 8). In case of SB, it showed an irregular shaped surface caused by abrasion of the glassy matrix and the reinforcing crystals, and exposure of needle-like crystals due to sandblasting procedure as shown in (Fig. 9).

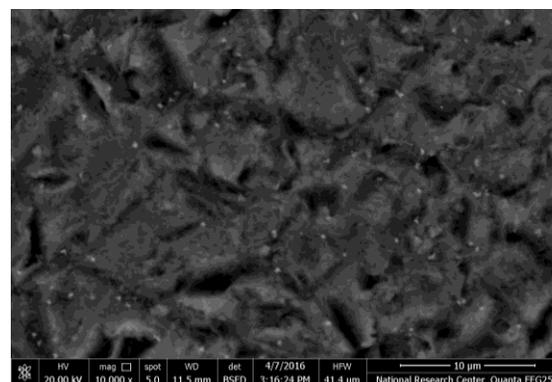
Fig. 9: ZLS plate (10000X) treated with sandblasting

On the other hand, SB showed abrasion of both the glassy matrix and reinforcing crystals, together with revealing needle-like crystals as shown in (Fig.9). Airborne particle abrasion is a routine step used to remove the reaction layer around pressed LDC, but it can be selectively

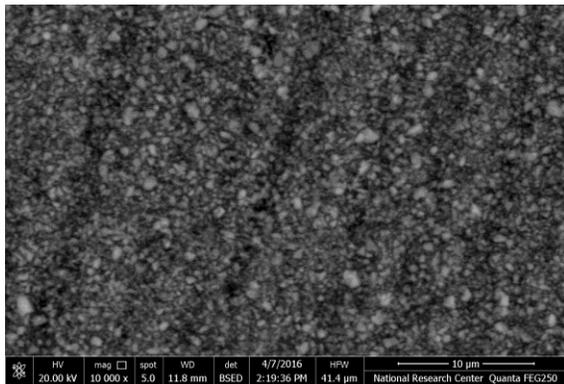
Fig. 10: RNC plate (10000X) with no surface treatment

RNC plate with no surface treatment showed a homogenous distribution of the barium glass and silica particles inside the matrix as shown in (Fig.10). While after the HF acid etching it showed the dissolution of the ceramic particles creating micropores as shown in (Fig.11). In case of SB, it showed an irregular surface resulting from the effect of the sandblasting particles on the resin matrix as shown in (Fig.12).

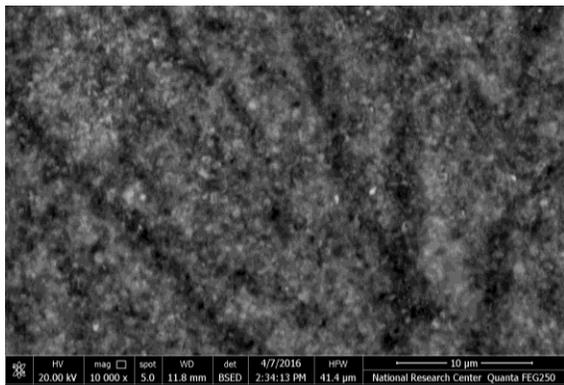
Fig. 11: RNC plate (10000X) treated with hydrofluoric acid etch
