THE DISCOVERY OF THE SARCOPHAGUS OF DJOSER AND THE RESTORATION OF THE STEP PYRAMID

Zahi Hawass

KEYWORDS: Step Pyramid, Djoser, Netjerikhet, Façade, Restoration, Imhotep, Faience.

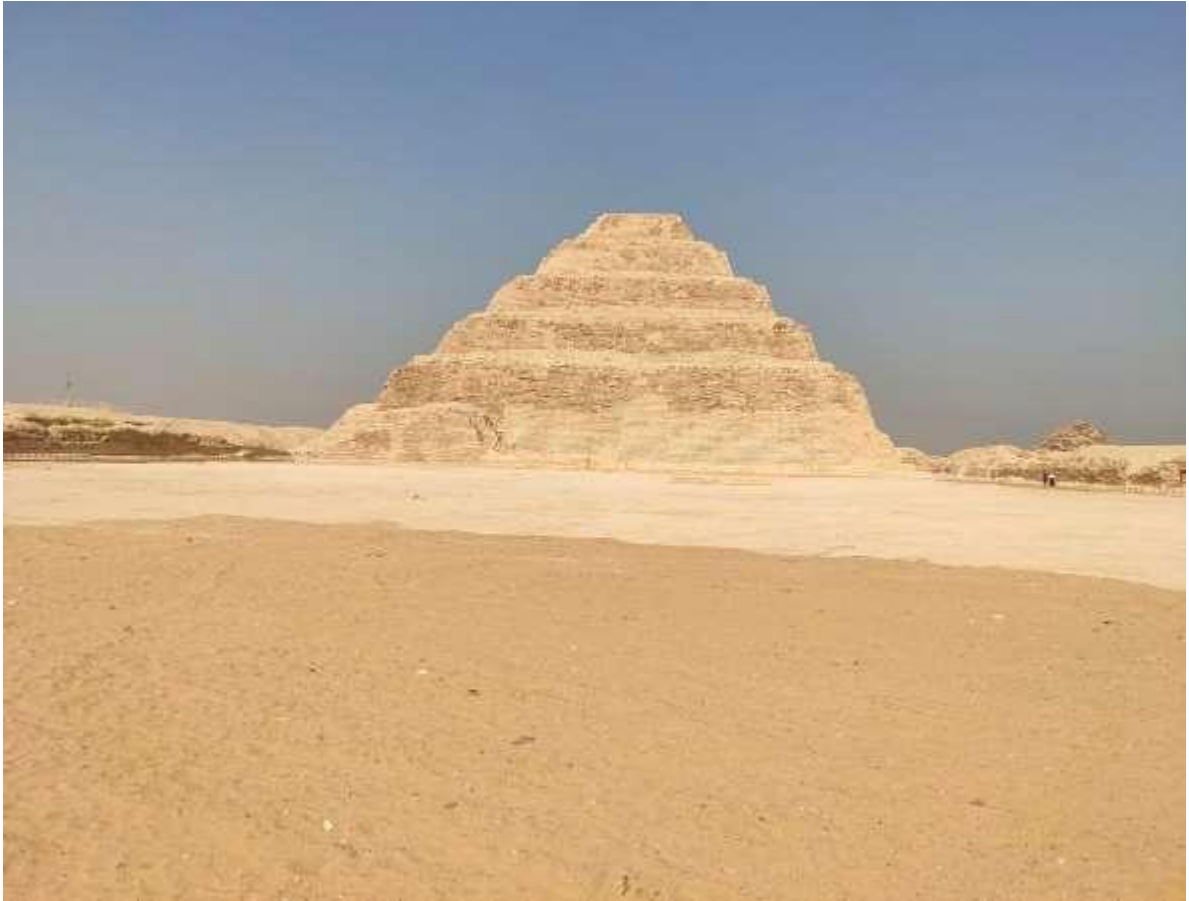
The Step Pyramid of Netjerikhet (also known as Djoser) is the oldest monumental stone structure in Egypt. Much of the pyramid's façade has suffered significant damage. On the north façade, we could see accumulation of dust and wind-blown sand, as well as, loose and falling block fragments [FIGURE 1]. We could also see the same patterns of damage clearly on the northeastern and northwestern corners of the pyramid, along with the western façade [FIGURE 2]. Moreover, previous restoration works on the south façade destroyed some of the pyramid's original design [FIGURE 3].

[FIGURE 1]: North façade © credit by HAWASS 2006.

The restoration team worked on removing the accumulated dust and sand that covered the blocks. The fallen blocks were buried under a great deal of sand and debris that needed to be moved so that the blocks could be restored. The thick layers of accumulated debris and sand were heavy, creating pressure on the interior structure of the pyramid. These layers contained a lot of salt that was causing the blocks to deteriorate and crack.

The team was able to collect all blocks that were loose under the sand, treated them immediately, and chose the best of them to be placed back onto the pyramid after filling the gaps with mortar. The mortar that was used consisted of the same ratio of limestone to sand used by the ancient Egyptians to construct the original pyramid. On the east façade of the pyramid, part of the original outer casing of *Tura* limestone remained. This casing was angled so that rainwater would run off. The holes and gaps in all four façades were cleaned and refilled.

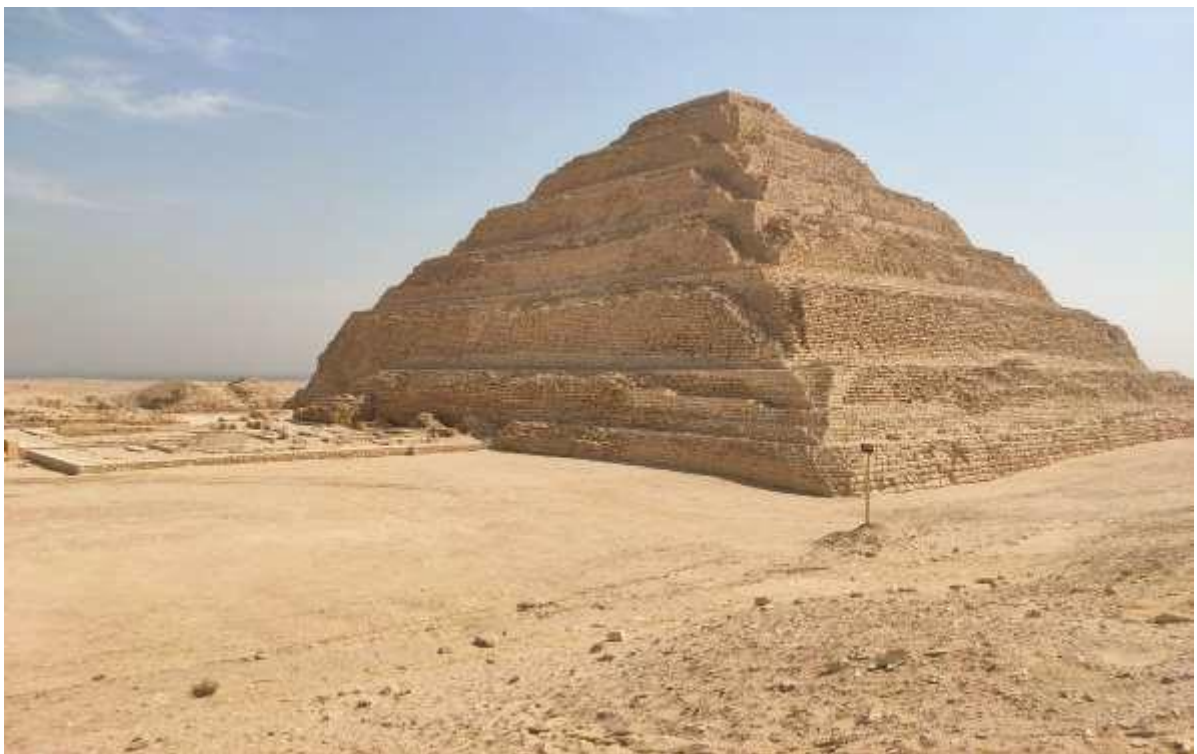
[FIGURE 2]: West façade ©credit by HAWASS 2006.

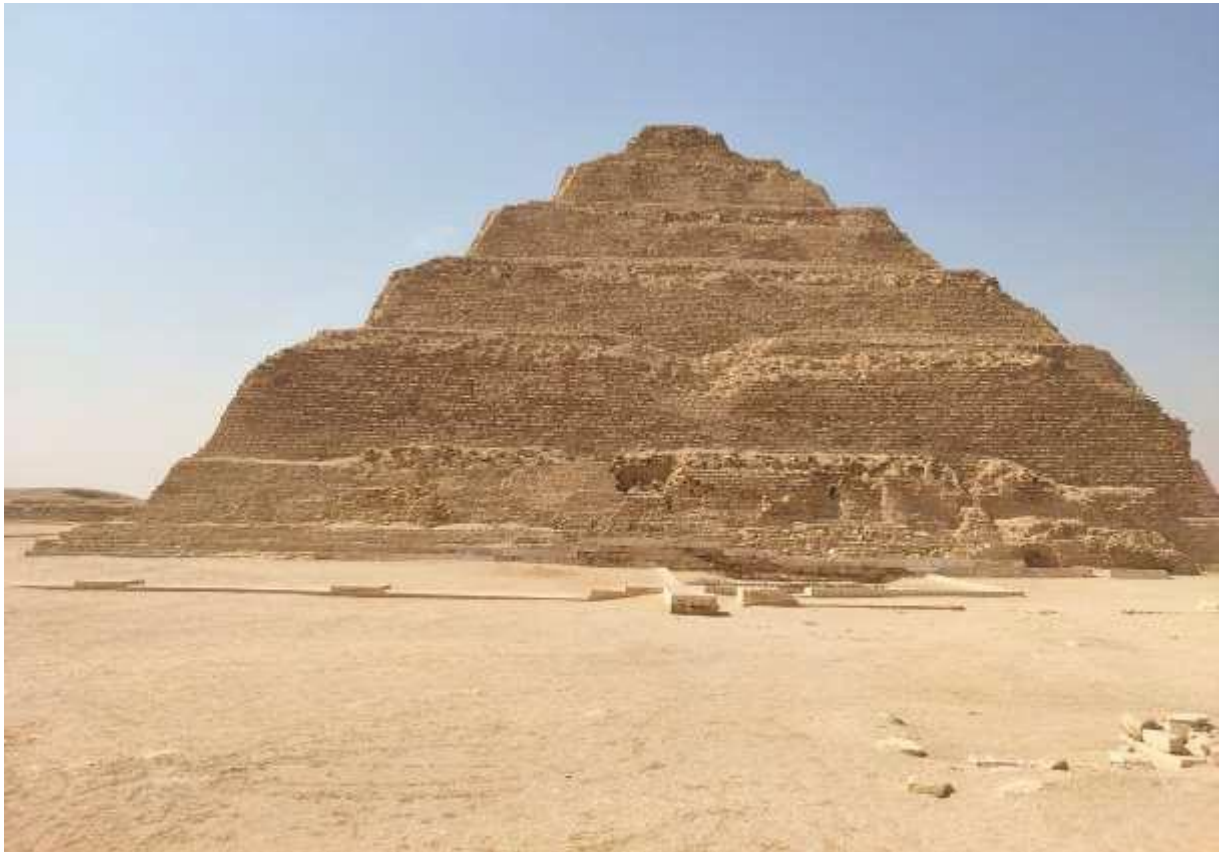
[FIGURE 3]: South façade ©credit by HAWASS 2006.

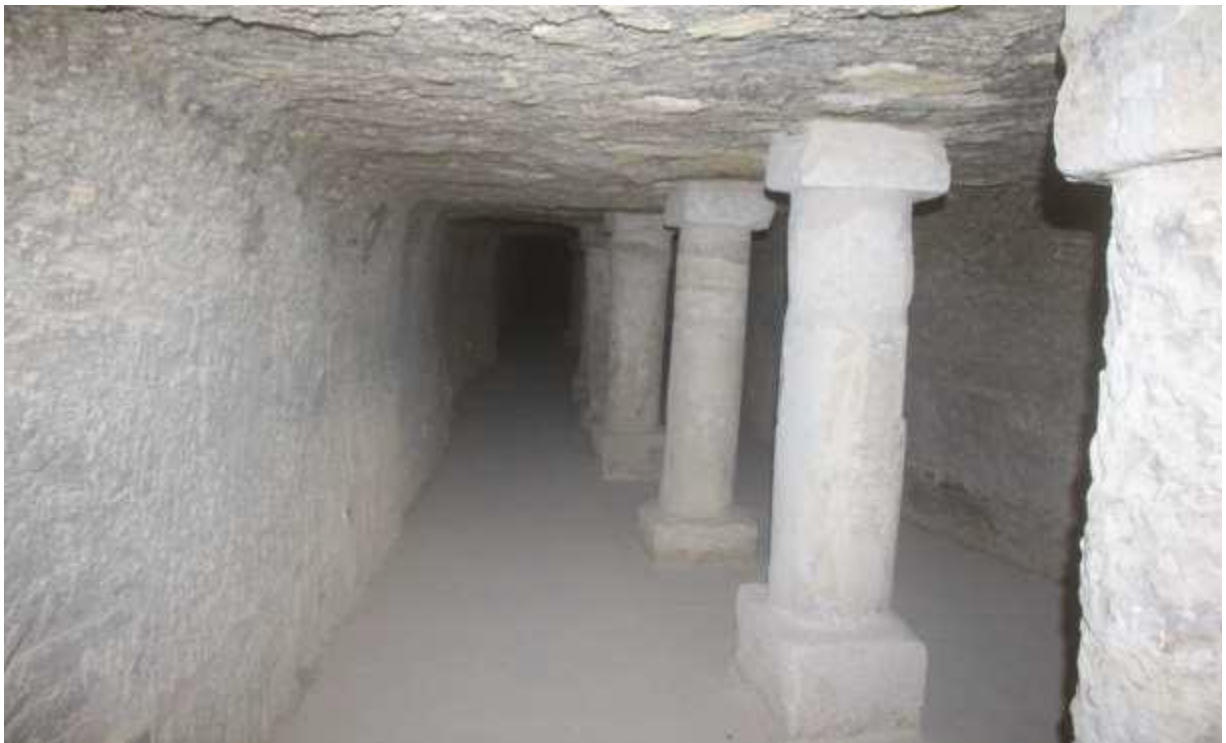
The south entrance in the superstructure was dug during the Saite Period (Dynasty 26). It is about 50.50 meters long, running south to north, and the width varies from 3 meters to 3.45 meters. It is 1.75 meters to 1.85 meters in height. The ceiling of this entrance was held up by a row of twenty small stone pillars. Some are square and some are circular, and all are stylistically similar to pillars dated to the New Kingdom. They may have been moved from a New Kingdom building at Saqqara during the Saite Period. Dynasty 26 is known for its veneration of earlier

periods, and Saite engineers built this entrance tunnel in order to remove debris from the original main shaft so that they could re-discover and restore the royal sarcophagus² [FIGURE 4].

[FIGURE 4]: inside the South entrance ©credit by HAWASS 2018

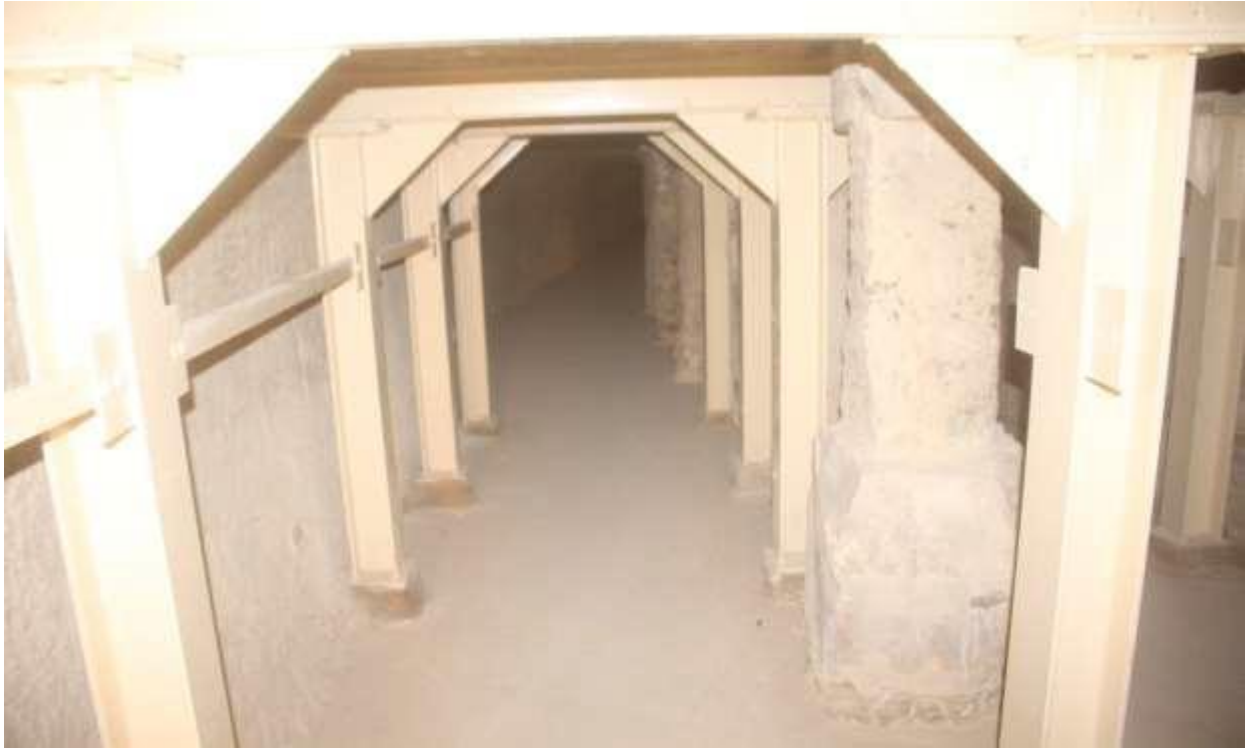
Additionally, we can see a natural crack in the ceiling of this tunnel, running from north to south and ending at the entrance. This was the reason for the installation of the pillars, to protect and support this tunnel. They also installed wooden beams to protect the workmen who cleared burial shaft. We can see these wooden beams on the upper part of the ceiling of the shaft. On the walls of this tunnel, there are open niches with the residue from burning on the sides; these may have been used for lamps to light the tunnel [FIGURE 5].

[FIGURE 5]: Restoration of the South entrance © credit by HAWASS 2018.

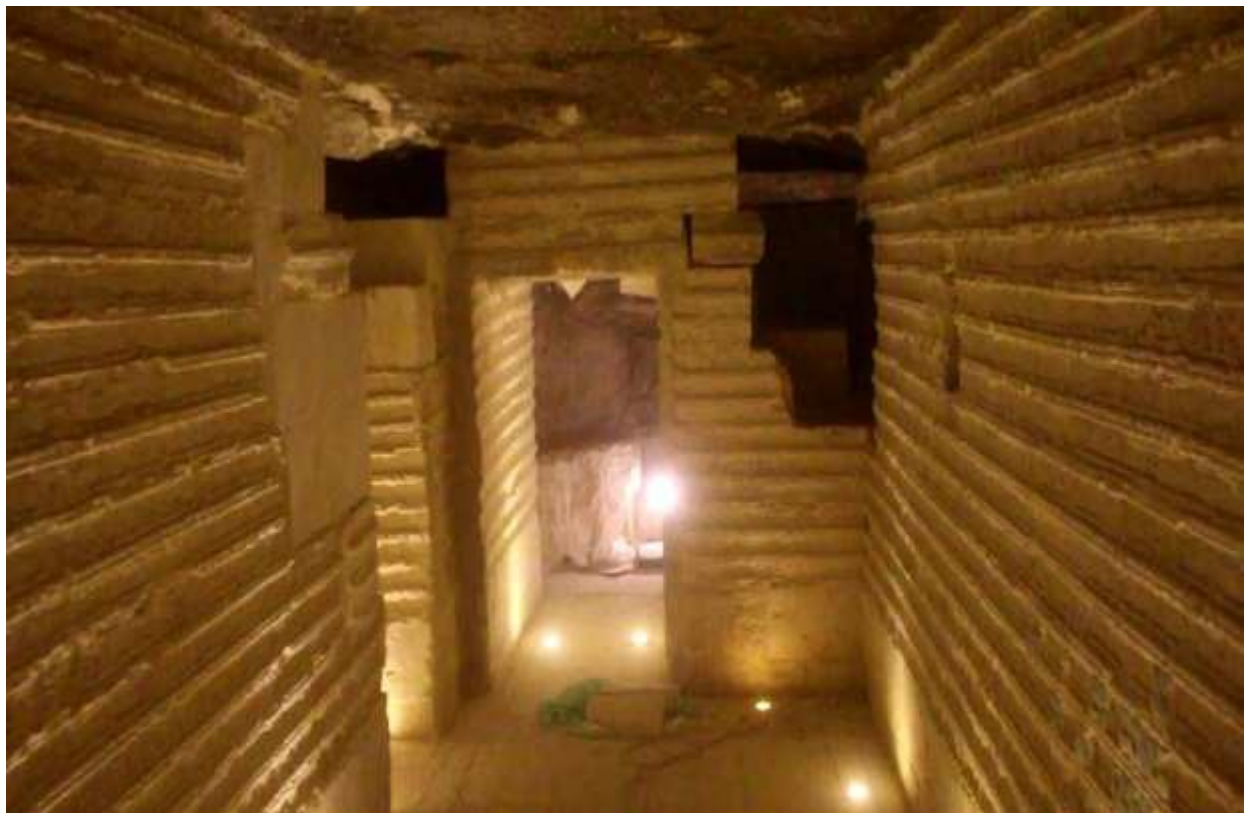
From the southeast corner of the sarcophagus chamber at the bottom of the burial shaft, there is a short tunnel leading to two rooms decorated with blue faience tiles. On the lintels of the entrances to these two rooms, we found the inscribed titles of Netjerikhet. The walls of the two rooms were cased with fine white limestone, with rows of blue faience tiles set into the walls. Each row is separated by horizontal bands of limestone carved to resemble linen ropes. This decoration is designed to mimic reed mats that would have covered the walls of actual buildings.

In this area, there is also some hieroglyphic graffiti that has been left on the stone blocks by the ancient workers. Moreover, paintings of stars painted in black ink can be found on the ceiling of the entrance that led to the room. On the south side of the faience room are three stelae that contained the names and titles of Netjerikhet, where he is also shown wearing the White Crown of Upper Egypt. The stelae are surrounded by rows of bluish-green faience tiles³. These rooms, as well as the wall stelae of Netjerikhet, were completely documented and restored [FIGURES 5-7].

[FIGURE 6]: Room of the faience Tiles © credit by HAWASS 2018.

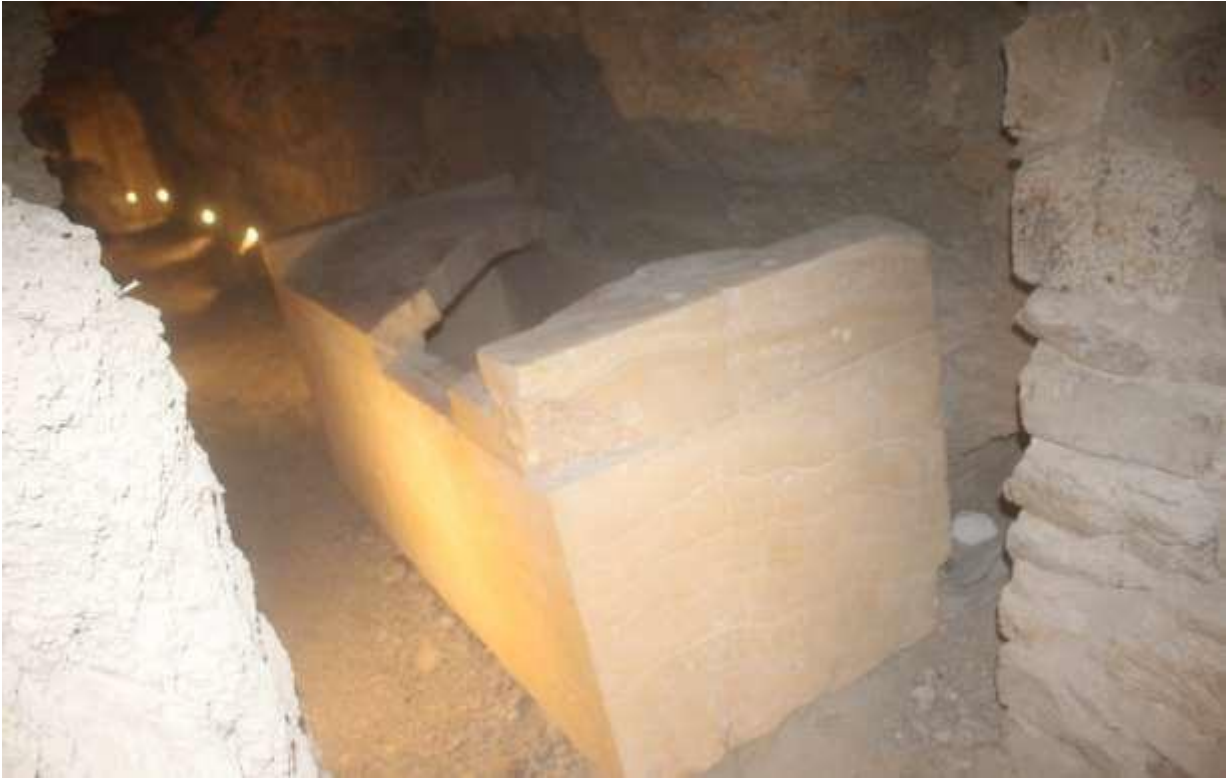
The second entrance to the fifth level is on the east side of the pyramid where a slope down in the bedrock leads to one of the eastern royal shafts. This entrance includes a series of passages and tunnels connected to each other, running both from north to south and from east to west. One of these tunnels runs from west to east and ends at a vertical shaft leading to the top, at the eastern part of the structure of the first mastaba. The walls of the fifth level are fragile and have been severely damaged because of the high level of humidity. All the tunnels and walls were documents, restored, and consolidated' [FIGURE 8].

[FIGURE 8]: The Alabaster Sarcophagus on the fifth level © credit by HAWASS 2018.

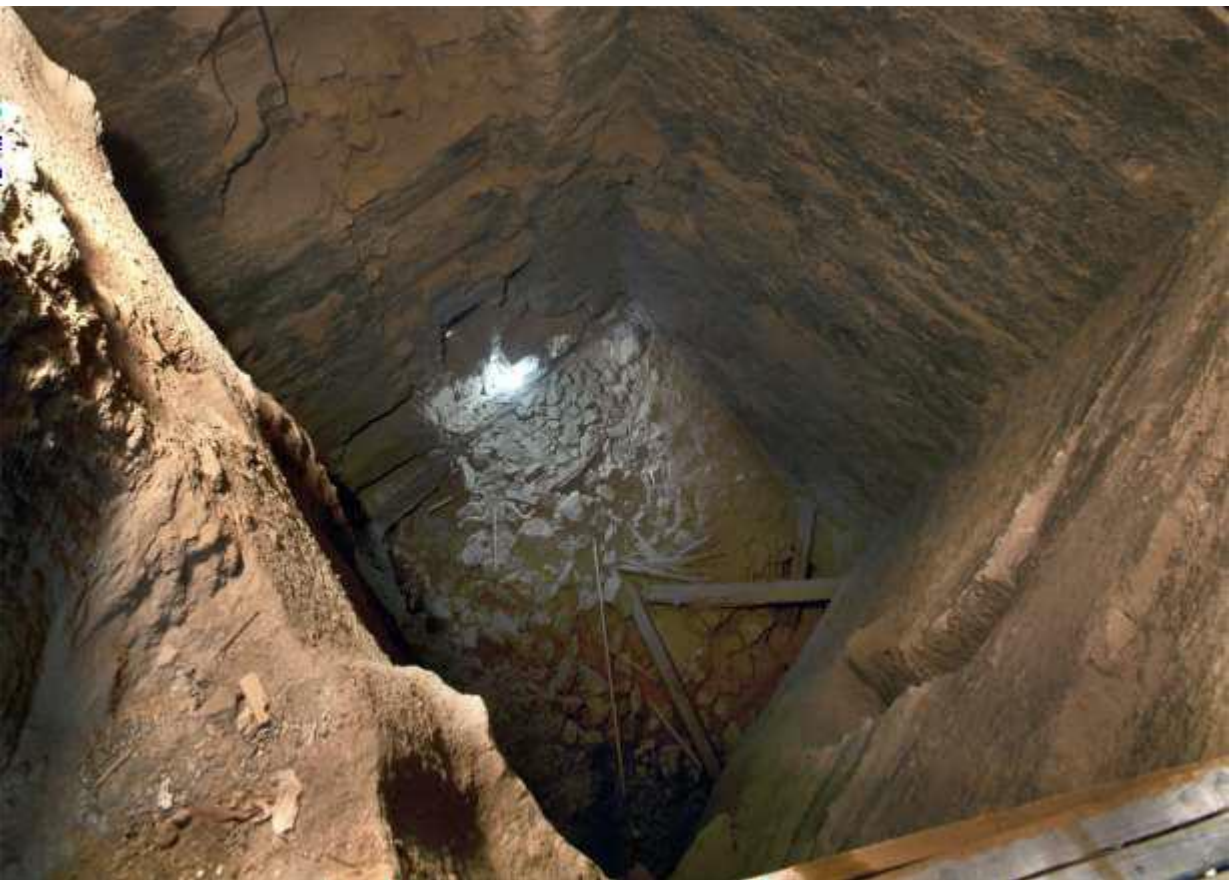
The main shaft inside the Step Pyramid was one of the major problems that we faced during the restoration project. We discovered that the burial chamber had never been excavated before, and the sarcophagus had never been found. The shaft contained a great deal of debris, including a great deal of stone rubble. Some of this debris came from the ceiling of the chamber itself. The situation was made worse by the earthquake of 1992. The shaft is square, measuring about 7 meters by 7 meters; its depth is about 28 meters. We removed more than 400,000 square meters of stones and rubble from this shaft to clear it.

We carefully examined the debris for any artifacts and saved the stones that could be used for the conservation of the shaft. We began to support the collapsing stone pillars and the walls of the burial chamber with supporting blocks. The mortar that was used for the restoration consisted of lime and sand in the same proportions as those used by the ancient Egyptians. All the entrances to the tunnels were also restored. The discovery of a granite sarcophagus, broken into 32 pieces, was a huge surprise. Its dimensions are 3.47 meters x 5.35 meters and it is 4.73 meters in height; weighing about 1.76 tons [FIGURE 9].

[FIGURE 9]: The Burial chamber before the removal of the sand and stones © credit by HAWASS 2018.

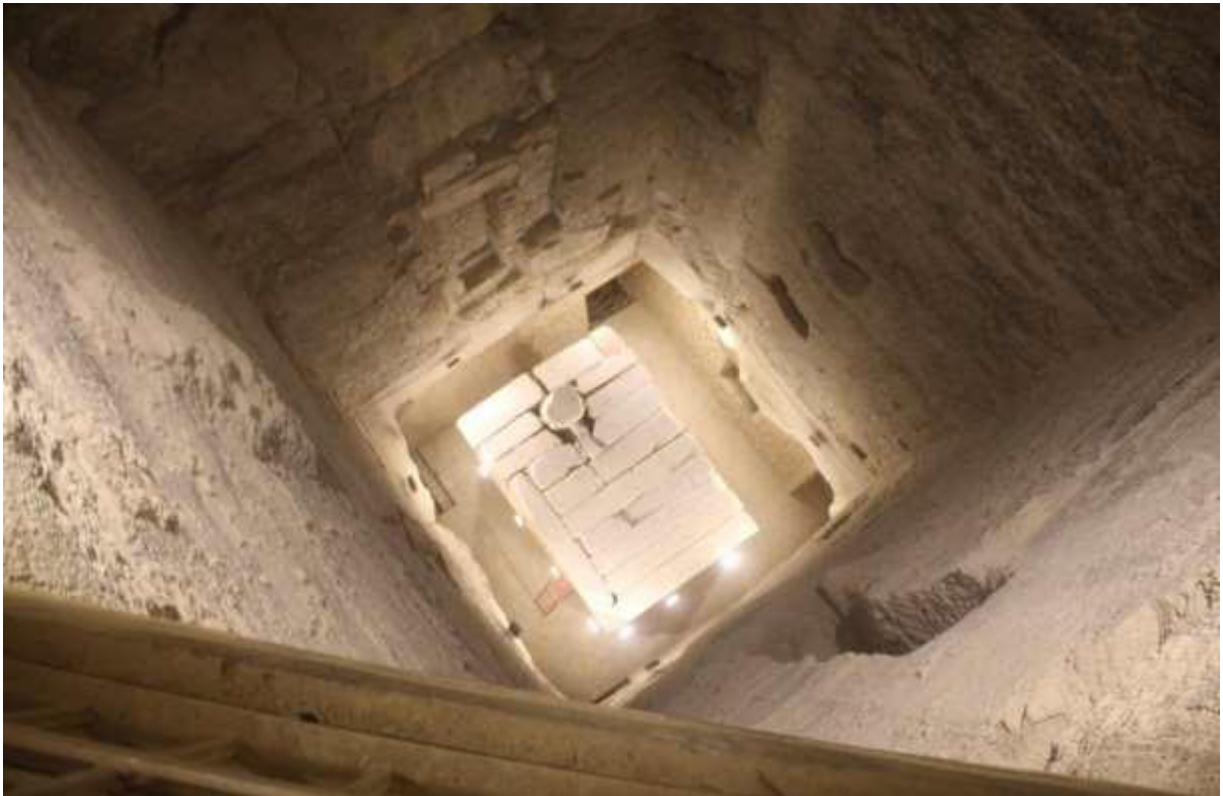
We also found an open area at the top lid of the sarcophagus, which contained a cylindrical stopper made of granite. This piece is about 3 tons in weight and was restored to its original location. The team discovered that the sarcophagus was resting on 18 blocks of limestone for support. All these blocks had been destroyed under the heavy debris that filled the chamber.

The limestone supports were consolidated along with the entire area underneath the sarcophagus. In the shaft, the team also found a number of blocks of Egyptian alabaster and limestone carved with stars. Some blocks had stars on one surface, while others had stars on both sides. This suggests that there was a calcite (travertine) ceiling decorated with stars in a burial chamber above the level of the one where the sarcophagus currently lies. That chamber had its walls cased in calcite (travertine). This is further supported by the higher level of the northern entrance into the pyramid compared to the level of the sarcophagus. This also suggests that it might have led to a room above the current burial chamber, which was destroyed when the ceiling collapsed [FIGURE 8].

[FIGURE 10]: The Sarcophagus in the Burial chamber © credit by HAWASS 2018.

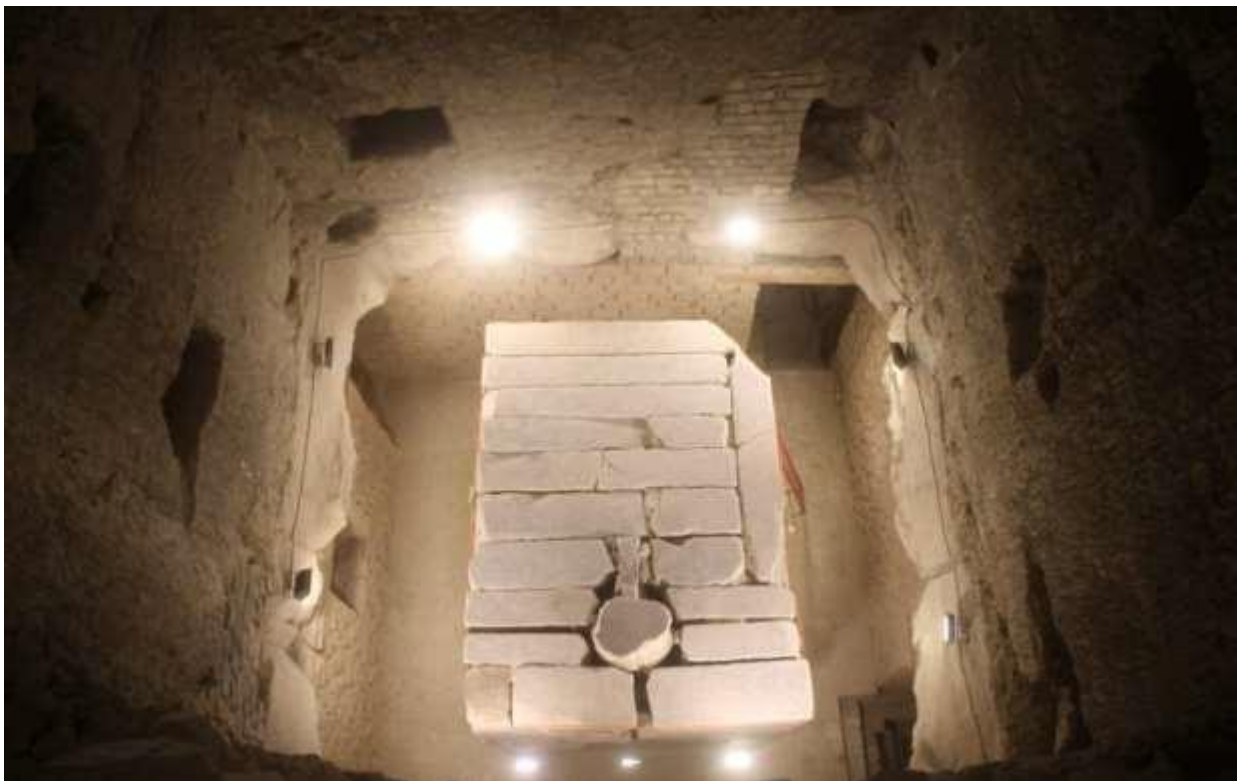
On the western corner of the shaft from the top, there is a tunnel or a *serdab* heading north. It runs for about 53 meters in length, with 1.20 meters in width, and a height of approximately 90 centimeters. Its end is blocked with stones but could have possibly led to the mortuary temple north of the pyramid. This tunnel was probably dug by tomb robbers, who were able to reach the burial chamber from the top through a vertical tunnel on the side of the shaft, leading directly to the burial chamber. [FIGURE 11]

[FIGURE 11]: The Sarcophagus ©credit by HAWASS 2018.

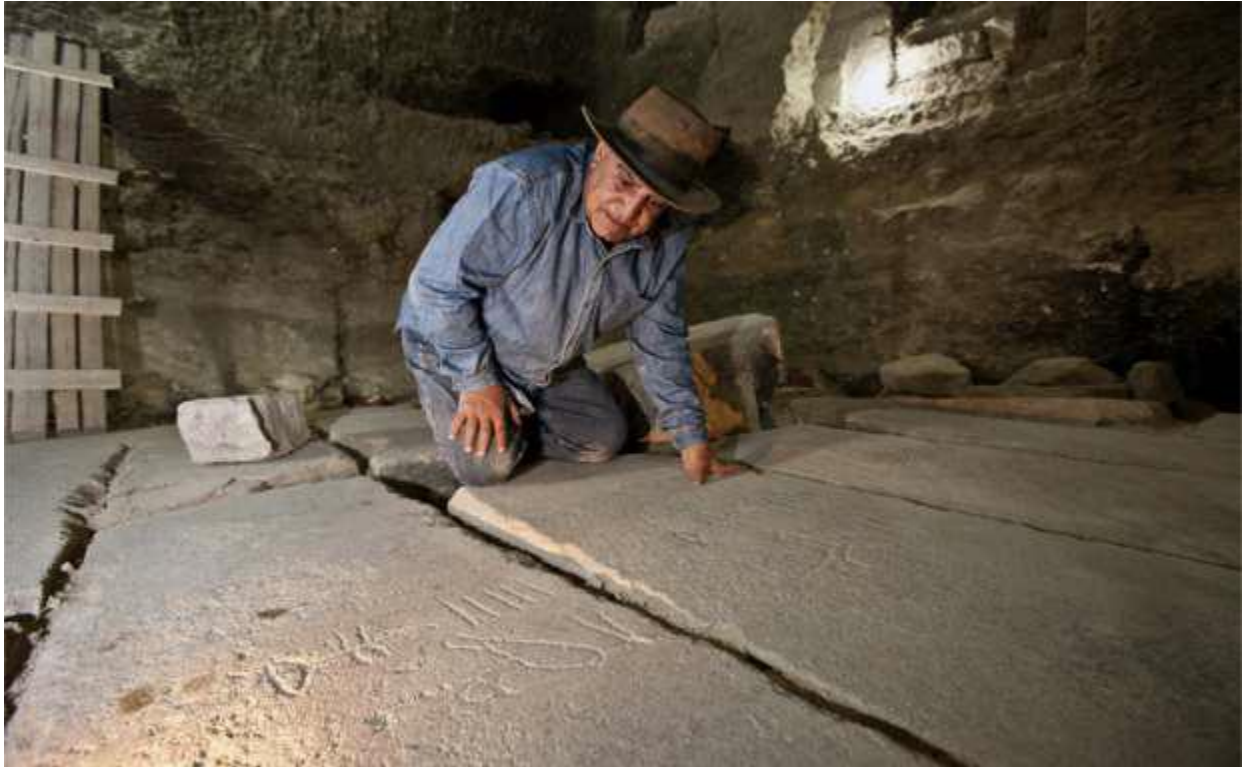
Openings present on the eastern and western sides of the shaft might have been used to install wooden beams to help raise the granite stopper of the sarcophagus using ropes after the burial of the king in the 3rd Dynasty. There are hieroglyphs on the granite blocks of the sarcophagus, which indicate the directions north and south in order to guide the workmen who placed the sarcophagus in the chamber.

On the northern side of the shaft is the main entrance to the burial chamber. It is cut into the bedrock and would have been blocked with stones after the burial of the king. The entrance located in the middle of the chamber is situated to face the sarcophagus. This area was restored and consolidated because it was too dangerous to leave it as we found it. Above this entrance are two stone lintels. This entrance originally led north to the outside of the pyramid, to the mortuary temple, and was closed during the third stage of the pyramid construction [FIGURE 12].

**[FIGURE 12]: The Sarcophagus and the Graffiti in Hieroglyphic North and South signs.
©credit by HAWASS 2018.**

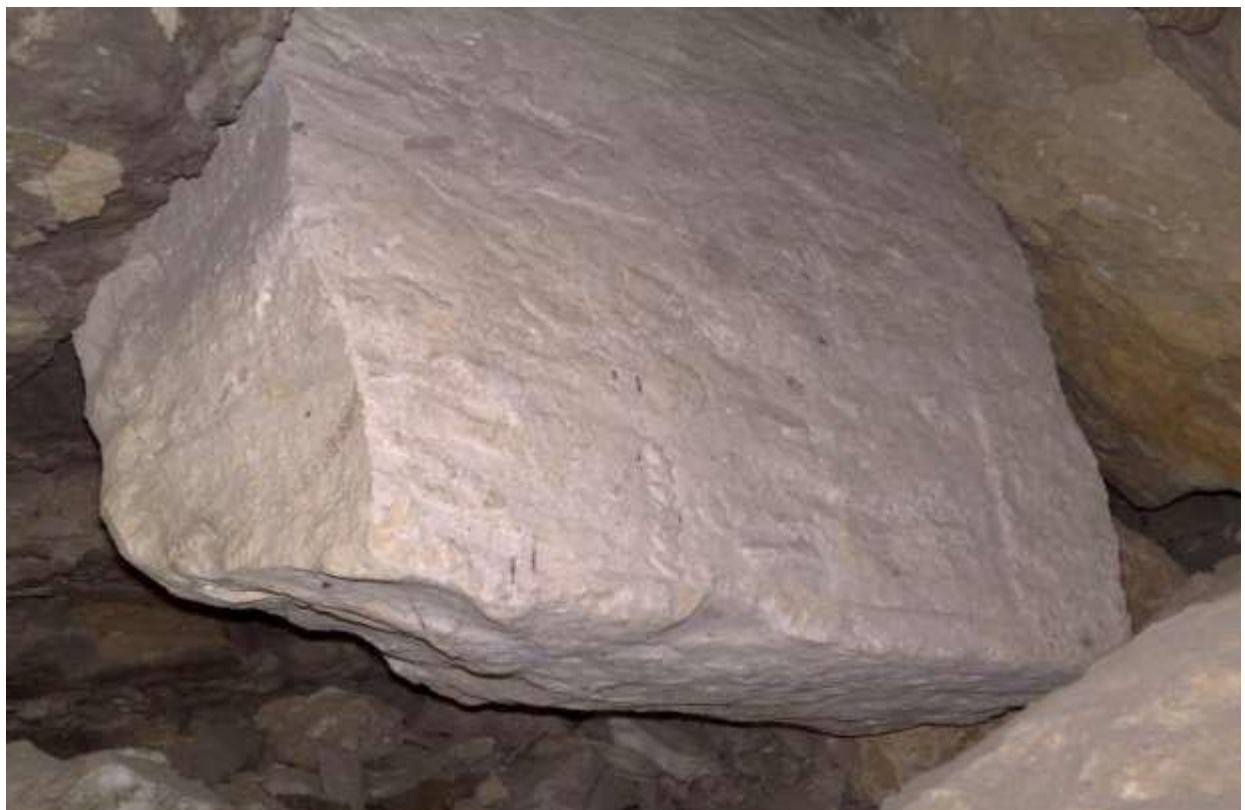
[FIGURE 13]: Stone on it the names of Djoser's daughter © credit by HAWASS 2018

The team found remains of three Late Period mummies, covered in painted *cartonnage*, inside the burial chamber during the removal of debris. They also found, a piece of limestone inscribed with the names of Netjerikhet and two princesses, one is the *s3t nswt* Int-kawes, and the second is Hetep-her-nebty.

š3t nswt – daughter of the king *š3t nst inkt*s and *st nswt ḥtp-ḥr nbty* [FIGURE 13].

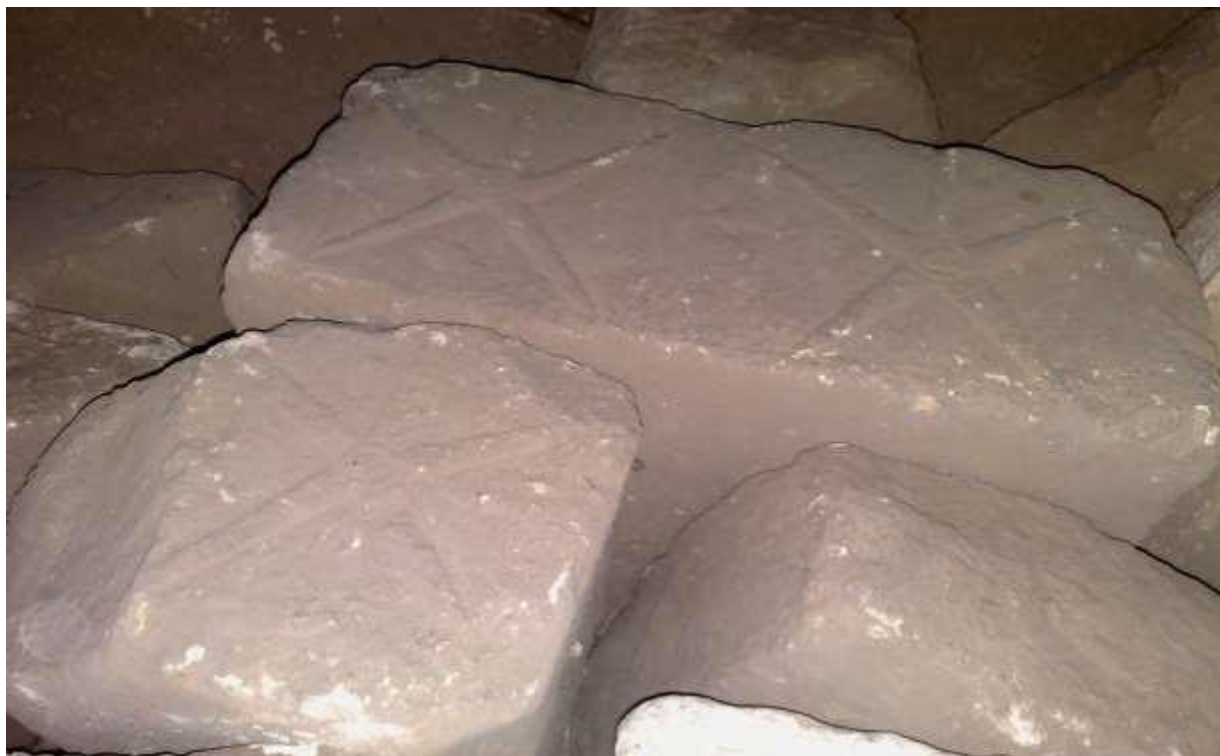
[FIGURE 14]: Stars on the Stones © credit by HAWASS 2018.

The team also found wooden tools such as mallets, faience chunks, and many types of pottery shreds, in addition to square and rectangular stone fragments decorated with stars, as mentioned above [FIGURE 14].
