White spot lesions: Resin infiltration technique

WHITE SPOT LESIONS: RESIN INFILTRATION TECHNIQUE

IAJD 2017;8(1):9-14.

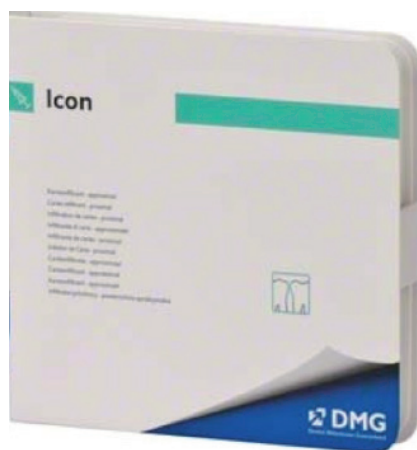
Fig. 1: Icon product.

Product description Icon is an innovative product for the micro-invasive treatment of dental lesions in proximal regions and on smooth surfaces.

Every kit includes:

1 icon-etch syringe : 15% hydrochloric acid, pyrogenic silicic acid, surface-active substances.

1 icon-dry syringe : 99% ethanol.

1 icon-infiltrant syringe: methacrylate-based resin matrix, initiators, additives.

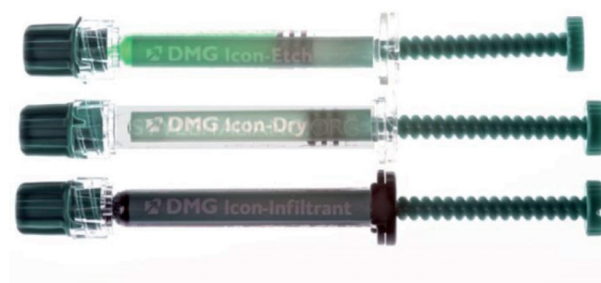
Fig. 2: Icon-Etch / Icon-Dry / Icon-Infiltrant syringes (icon,DMG,Hamburg,Germany).

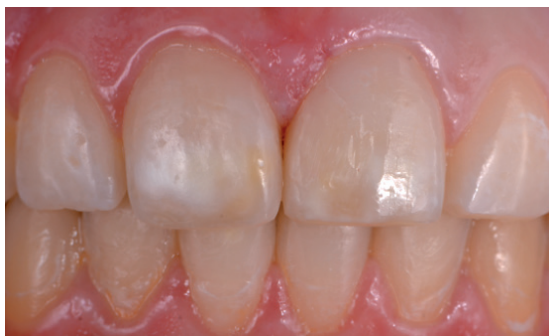
Fig. 3: Initial situation.

The spots are easily visible in the frontal view of the anterior teeth: a big white spot on tooth number 21 and a small one on tooth number 11. This young patient was looking for an esthetic solution for these defects in her smile (Fig. 3). After cleaning the affected teeth, a rubber dam was placed to ensure a good isolation (Fig. 4). Then, hydrochloric acid (IconEtch 15%HCL) was applied on the lesions for 2 minutes (Fig. 5). This acid removes the hypermineralized enamel on the surface and helps the resin reach the ceiling of the lesion to have a successful esthetic result. After rinsing for 30 seconds to eliminate all the etchant (Fig. 6), icon-dry (99% ethanol) was

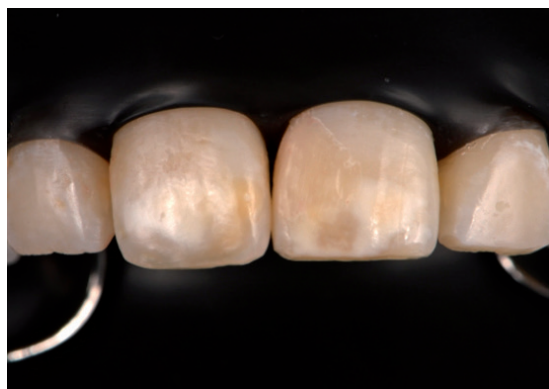
Fig. 4: Isolation with a rubber dam.

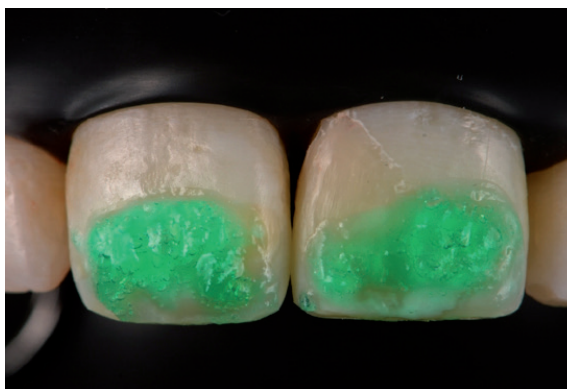
Fig. 5: Etching with 15% hydrochloric acid.

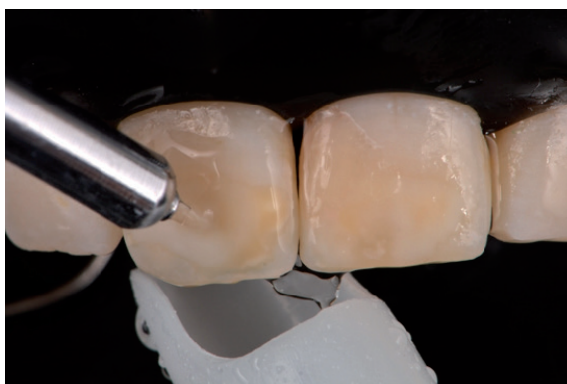
Fig. 6: Rinsing for 30 seconds.

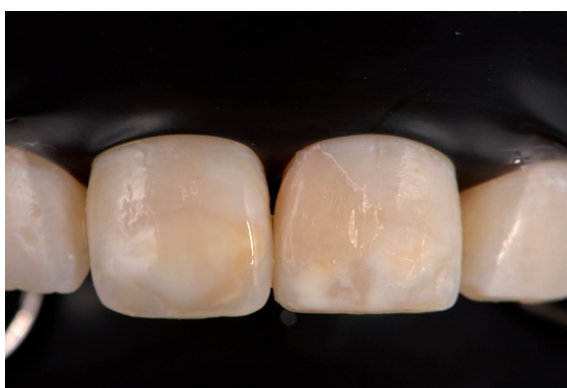
Fig. 7: First application of Icon-dry.

applied for 30 seconds to desiccate the lesion and to eliminate all the water in the pores of the lesion in order to have a good adhesion with the resin (Fig. 7).

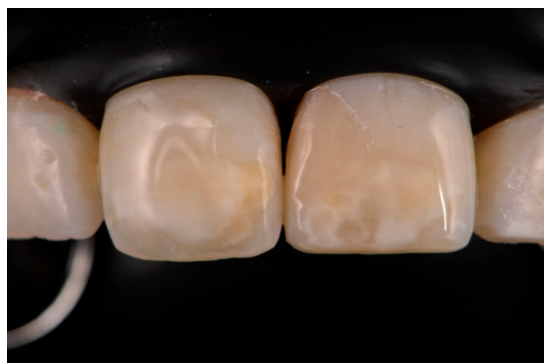
Fig. 8: Second application of Icon-dry.

This stage is very important because it gives an overview of the final esthetic result. If the lesion is still visible after applying the icon-dry, the etching protocol has to be repeated and the icon-dry product applied again (Figs. 8, 9). If not, the resin (Icon-infiltrant) can be applied for 3min (Fig. 10). It is a very low viscosity, TEGDMA-based resin. It uses capillary action to infiltrate and goes very deep into the lesion. All the excess in the buccal surface has been eliminated using a microbrush (Fig. 11) and in the proximal area using dental floss (Fig. 12) [10 - 13]. Note that this resin appears slightly yellow since it contains camphorquinone. After the

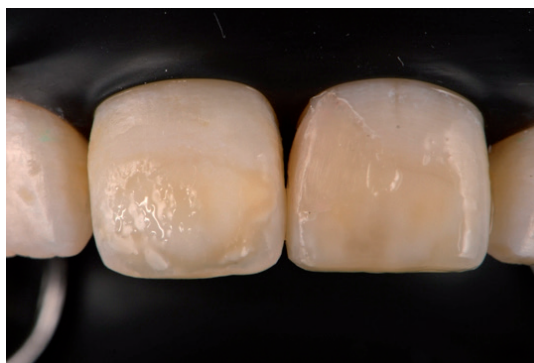
Fig. 9: Final application of icon-dry.

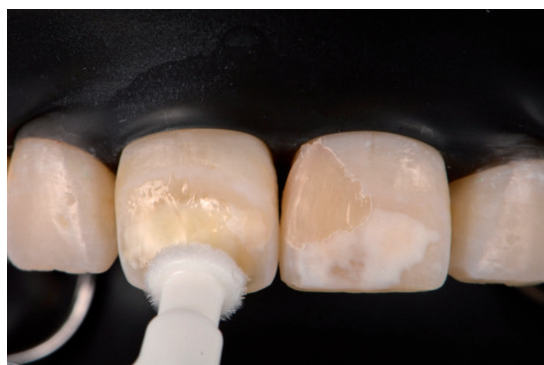
Fig. 10: Application of the resin.

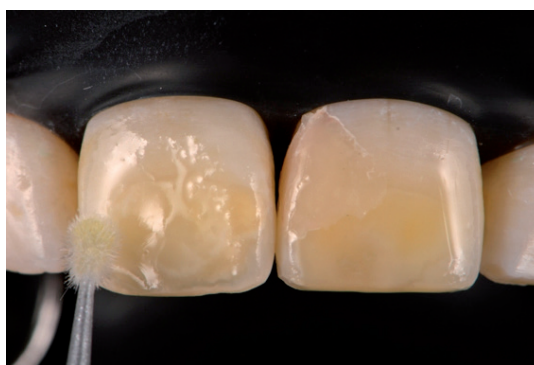
Fig. 11: Removing the excess with a microbrush.

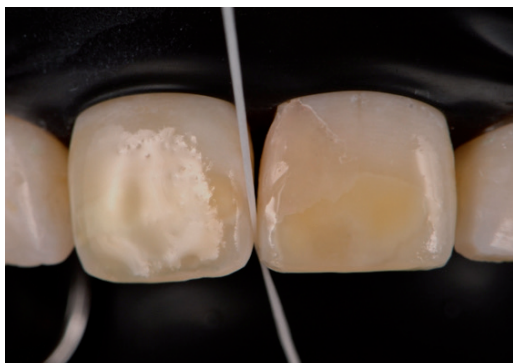
Fig. 12: Removal of the excess using dental floss.

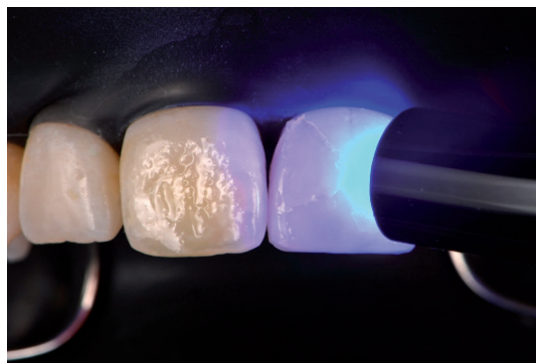
Fig. 13: Light curing for 40 seconds.

photopolymerization which was done for 40s (Fig. 13), the yellow tinge will disappear because the camphorquinone has been consumed. Studies showed that this resin has a high staining potential mainly if the patient is a high consumer of teeth-staining food and beverages [14, 15]. Therefore it should be always covered with a layer of composite. In this case, nanohybrid composite (Z350 enamel A1) was used (Fig. 14).

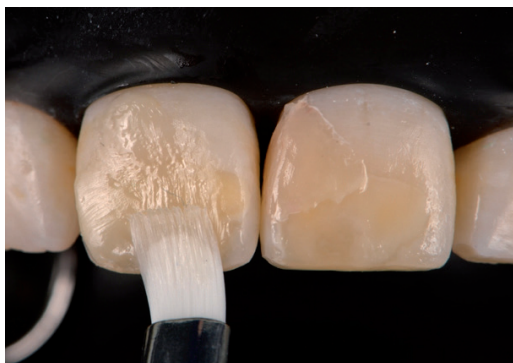
Fig. 14: Covering the resin with a layer of composite.

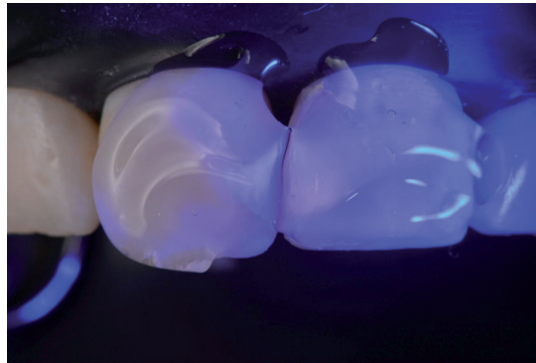
Fig. 15: Light curing through glycerin.

At this stage and before applying the composite, we don't need to apply bonding since the resin itself is an adhesive. The composite was light cured for 20 seconds (Fig. 15) then polished with diamond burs, a multiblade bur and wheels (Fig. 16). The figure 17 shows the final esthetic result obtained in a conservative way .

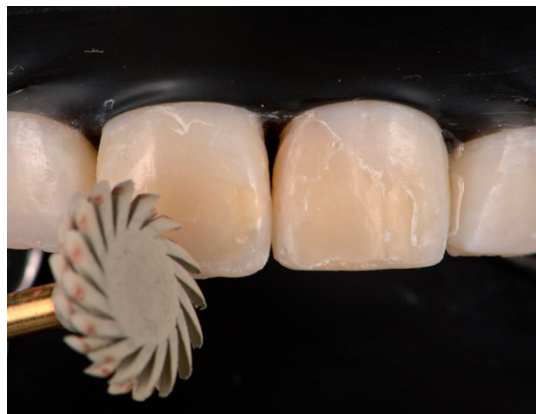
Fig. 16: Polishing the treated teeth.

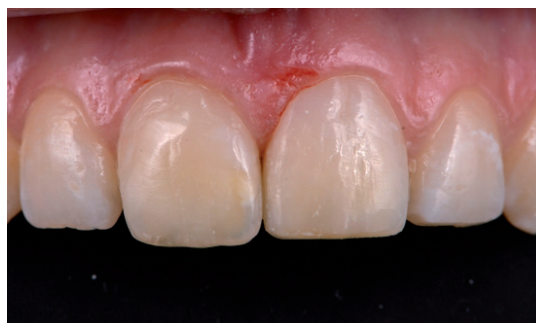
Fig. 17: Final result.
