Management of pulpal floor perforation using Biodentine™ : Case report

MANAGEMENT OF PULPAL FLOOR PERFORATION USING BIODENTINETM: CASE REPORT

Keywords: Furcation perforation, repair, MTA®, Biodentine™, case report

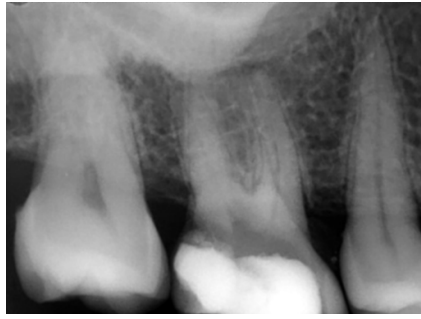
The preoperative periapical radiograph showed the presence of a temporary restorative material with a normal apparatus of the periodontal structures (Fig. 1).

Fig. 1: Periapical radiograph showing the preoperative status of the tooth 16.

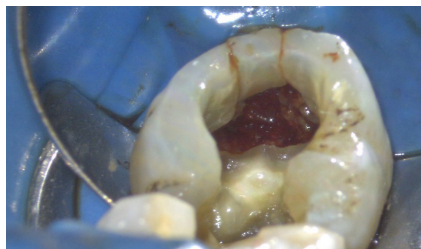
When the temporary restorative material was removed, a perforation in the pulp-chamber floor was clinically detected (Fig. 2).

Fig. 2: Clinical view showing the perforation area at the furcation level.

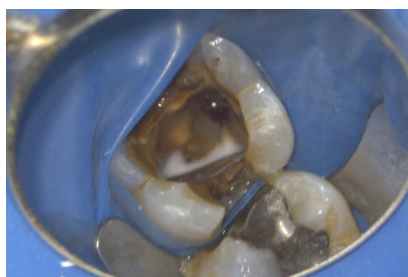
The perforation contained a newly formed soft tissue. After initial hemostasis, the granulation tissue was removed with a sharp spoon excavator. The furcal perforation was irrigated with 2.5% sodium hypochlorite and then with normal saline (Fig. 3).

Fig. 3: Clinical view showing the pulp chamber just after the irrigation protocol.

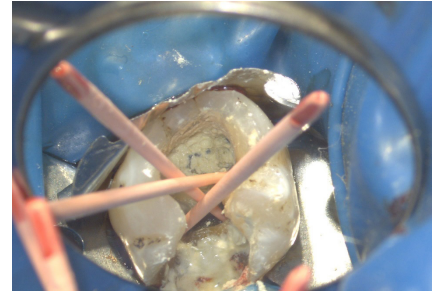
The three canals were negotiated with K-files, and the coronal enlargement of the canal orifices was conducted with OneFlare (MicroMéga). Gutta-percha points were placed in the canals during the application of the repair material (Biodentine™) to avoid their obstruction (Fig. 4).

Fig. 4: Clinical view under the dental operating microscope (Leica M320) of the furcal perforation repair of the tooth 16 using Biodentine™.

Biodentine™ was prepared following the manufacturer's instructions and was applied using MTA gun and Machtou plugger (Dentsply Maillefer).

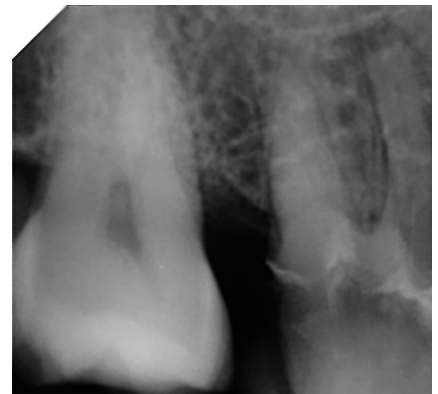
After that, Biodentine™ was covered with Cavit™, a temporary restoration material (3M ESPE) (Fig. 5).

Fig. 5: Immediate radiographic image after perforation sealing using Biodentine™.

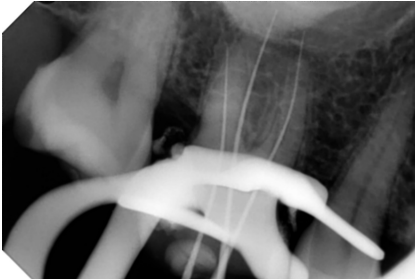
During the patient's second appointment, the temporary coronal temporary restoration was removed. The working length was determined radiographically (Fig. 6).

Fig. 6: Radiographic working length determination.

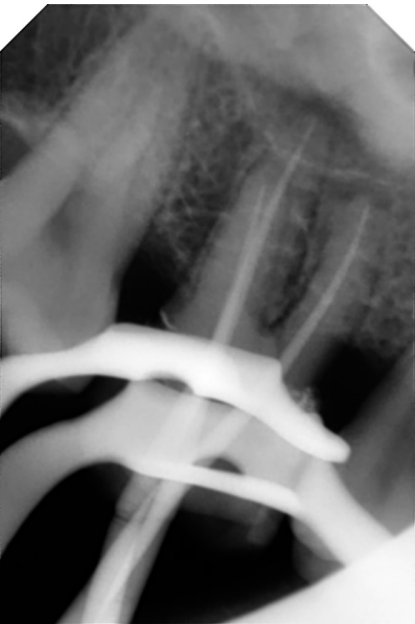
The root canals were cleaned with 3.25% sodium hypochlorite and shaped in a crown-down technique, using rotary files (NiTi Rotate, VDW, Germany). Next, they were dried with paper points and filled using the lateral condensation technique (Fig. 7) (Fig. 8).

Fig. 7: Radiograph showing master cone verification after chemo-mechanical preparation of root canals.

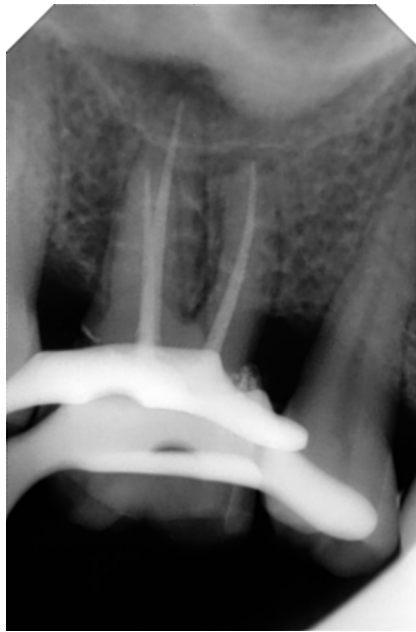
Fig. 8: Post-operative periapical radiograph showing the filled root canals and the Bio-dentine™ repair material placed over the furcation perforation.

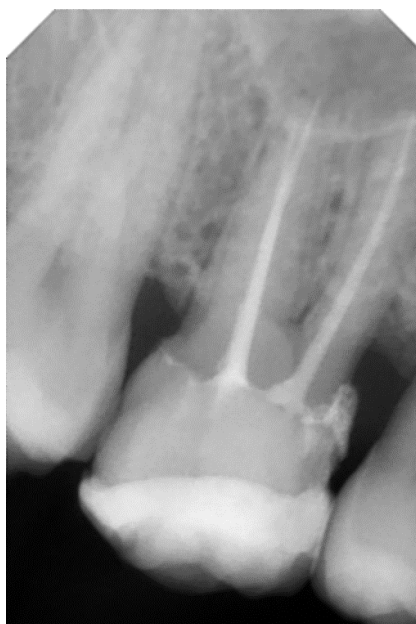
The post-endodontic coronal restoration was performed using Bio-dentine™ followed by composite restoration (Fig. 9).

Fig. 9: Post-operative periapical radiograph of the tooth 16.

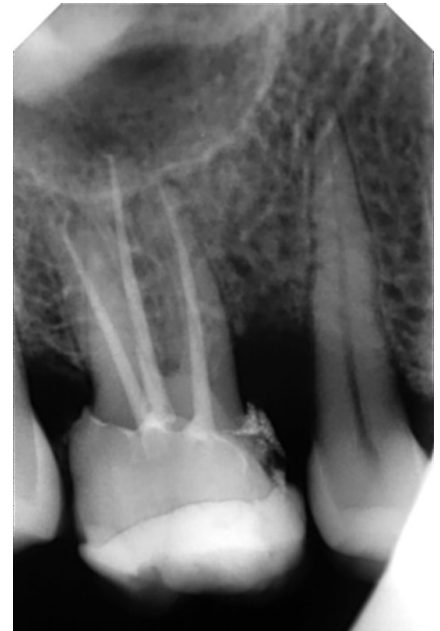
After this treatment, the patient was asked to return for a check 4 months later (Fig. 10) and for another one 12 months later (Fig. 11). The re-examinations showed that the tooth was asymptomatic. No tenderness to percussion was detected. The tooth was functional and the sulcus probing revealed normal values (1-3 mm). In addition, the radiographic examination showed adequate root canal filling and an adequate repair of the perforation site. Finally, no enlargement of the periodontal space was detected.

Fig. 10: Post-operative radiograph at 4 months follow-up.

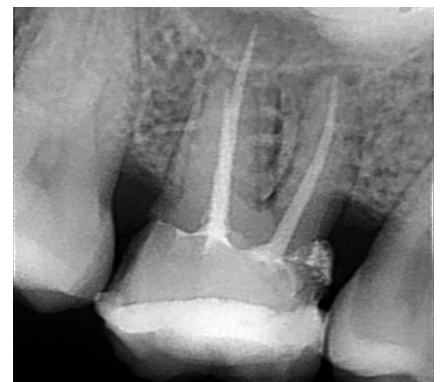
Fig. 11: Post-operative radiograph at 12 months follow-up.
