STRENGTHENING OF PRESTRESSED CONCRETE BOX BRIDGE AFTER FIRE EXPOSURE

This paper presents inspection, materials testing, field testing and parametric finite element analysis of a pre-stressed concrete box girder bridge after fire exposure. A detailed inspection of the fire-exposed bridge was performed through visual checking, photo examinations, and hammer detection. Samples of the concrete cores and reinforcing bars were tested; the residual strengths of the building materials (concrete, reinforcing bars and prestressed strands) were estimated. Furthermore, the temperatures at various depths were estimated. The data from field studies were used to validate finite element models. The structural behaviors of the original bridge prior to fire exposure were obtained via instrumentation from a reference bridge not exposed to fire. The static proof load test deflection results indicate that the stiffness decreased by approximately 23% after fire exposure and no longer satisfied the design requirement. The measured fundamental frequency of the fire-exposed span was approximately 97% of that of the original span and the theoretical fundamental frequency, indicating that the fire had littl

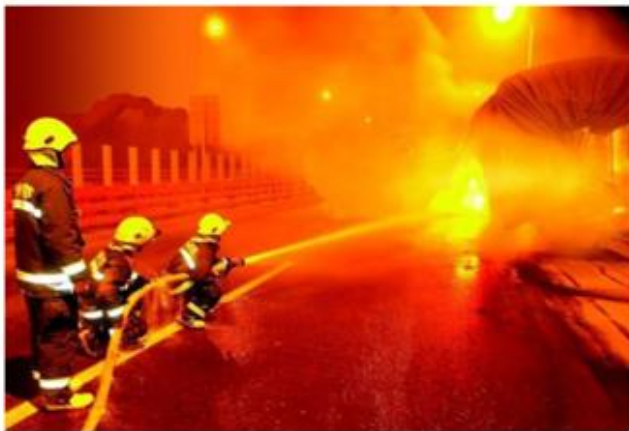
Fig. 1. Fire accident on a bridge deck.

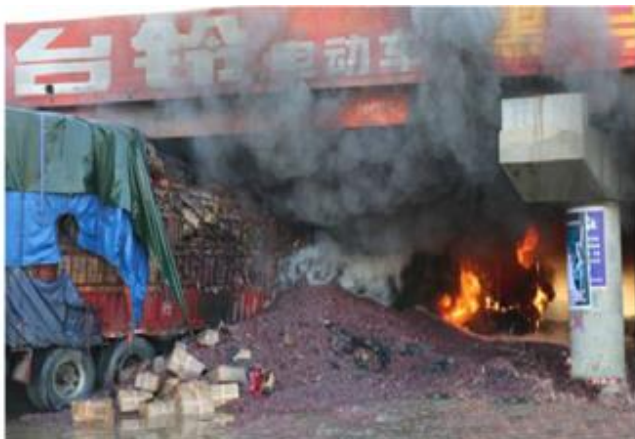
Fig. 2. Fire below the bridge span.

below bridge spans. Fig. 2 shows a fire caused by

an accident involving a fireworks truck below an overpass span that broke out at the Daqi Road/G4 Expressway interchange near Hebi City in Henan Province, China. Additionally, some Chinese urban residents store flammable sundries, such as timber or straw, below bridge spans for use as shelters, and these materials have been one of the major causes of bridge fires. A fire can damage a bridge to different extents according to the fire's position and the properties of the fire [1–4].

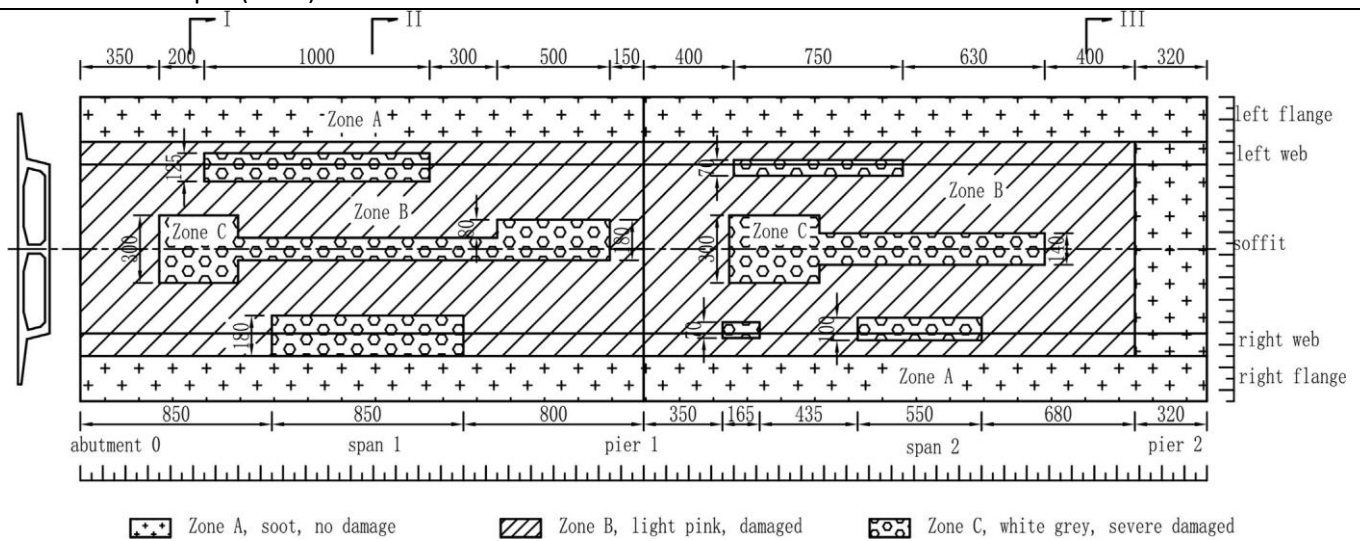
To develop the fire-damaged Model B, the fire-affected area of the girder was divided into three zones (zones A, B and C) depending on the fire damage level, as shown in Fig. 17. Zone A was observed to have no visible damage except soot on the surface; hence, the material properties and section sizes of zone A were not changed compared with those of Model A. Zone B appeared to have cracking and a light pink color on

Fig. 17. Divided zones of the fired beam in Model B.

the surface. Due to the degradation of materials by the fire, the material strength properties of zone B were decreased according to the material testing results. Because no clear spalling or cover loss was observed, the section size did not have to be reduced in zone B. Zone C was the most severely fire-damaged area. Hence, both the material strength properties and section size of zone C were reduced. Due to the exposure of the reinforcing bars in zone C, the reduced size of the sections was assumed to be 4 cm, corresponding to the clear cover thickness. Fig. 18 illustrates the reduced sizes of various cross sections. The parameters of different zones in the FEMs are listed in Table 6. The prestressing of the N9 tendons is regarded as retaining 90% of the room-temperature prestressing according to the previous results in this paper.
